Sustainable Engineering Internship

2018 Final Report

Jacob Shactman, Gabby Peralta, Laurel He, Takeru Nishi

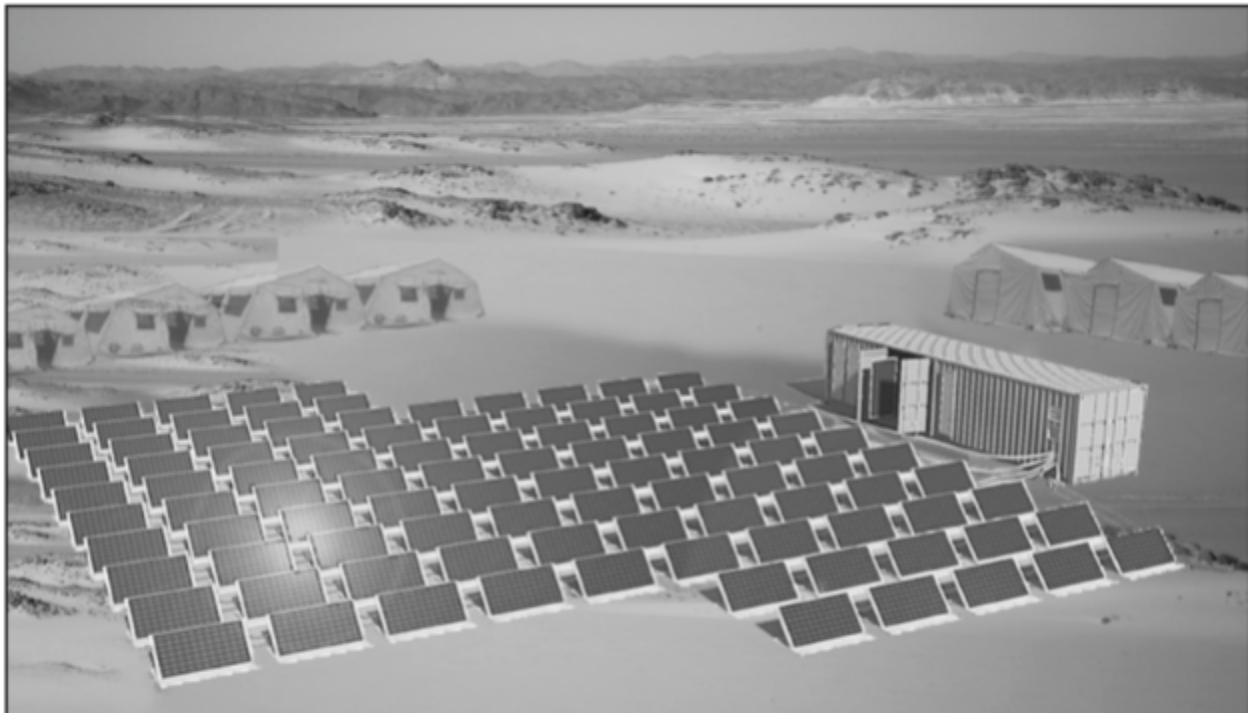
SML received a donation of a Mobile Renewable Energy Unit (MREU) in 2017 from a Cornell alumnus, Sean O'Day. Although originally planned for military use in arid and remote desert conditions, the unit had to be reconfigured to allow for all components to be installed in the Kingsbury house. The solar panels were placed on the either side of the roof, and the batteries, charge controllers, and inverters were placed in the basement. This new setup allowed for consolidation of the unit into one confined area. A graphic of the original MREU setup is shown in figure 1.

Figure 1: Original MREU Setup

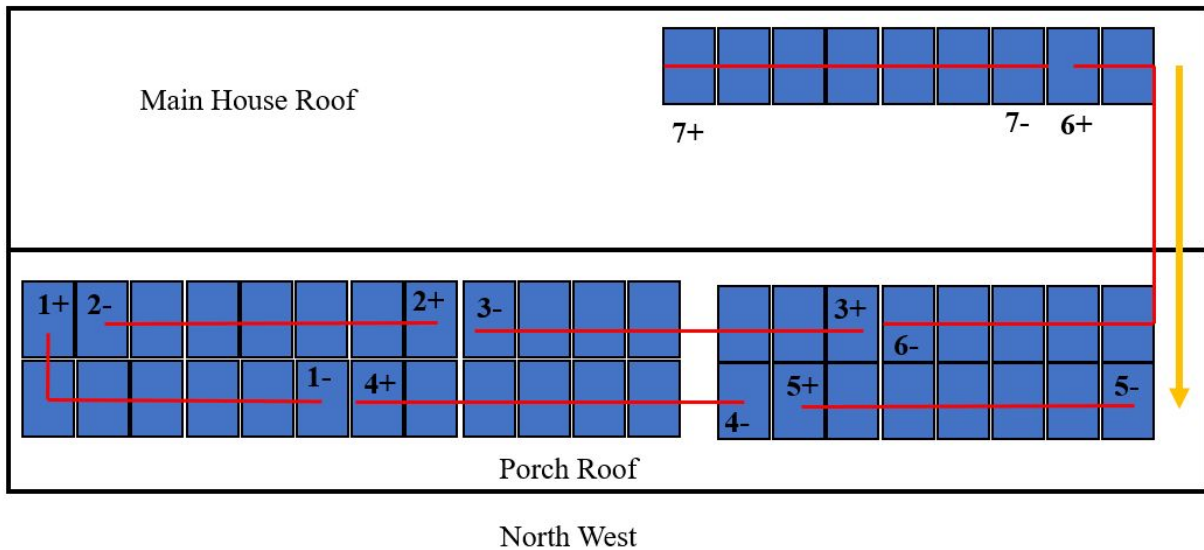
There are 14 Arrays on K-House, with two arrays assigned to each charge controller. Though not shown in the following illustrations, the arrays on the porch roof are oriented at a shallower angle than those on either side of the main roof.

Figure 2: Orientation and Numbering of Solar Arrays on the North West Side

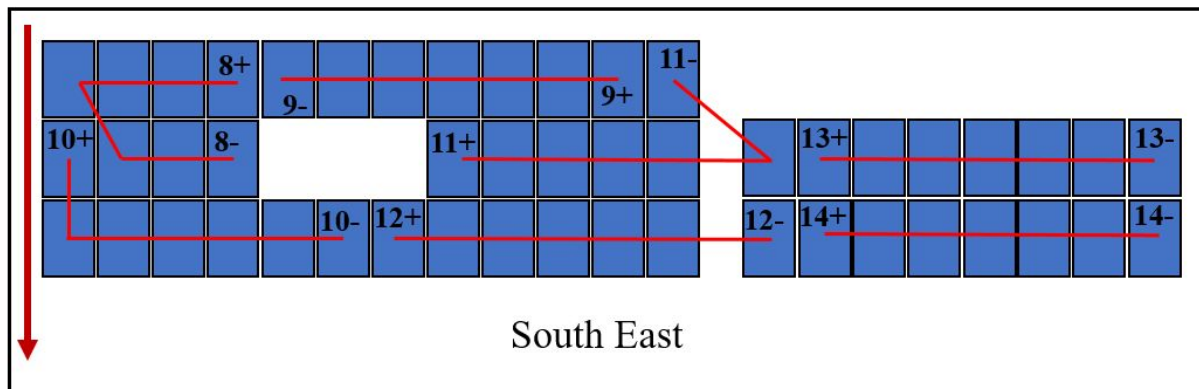
Figure 3: Orientation and Numbering of Solar Arrays on the South East Side

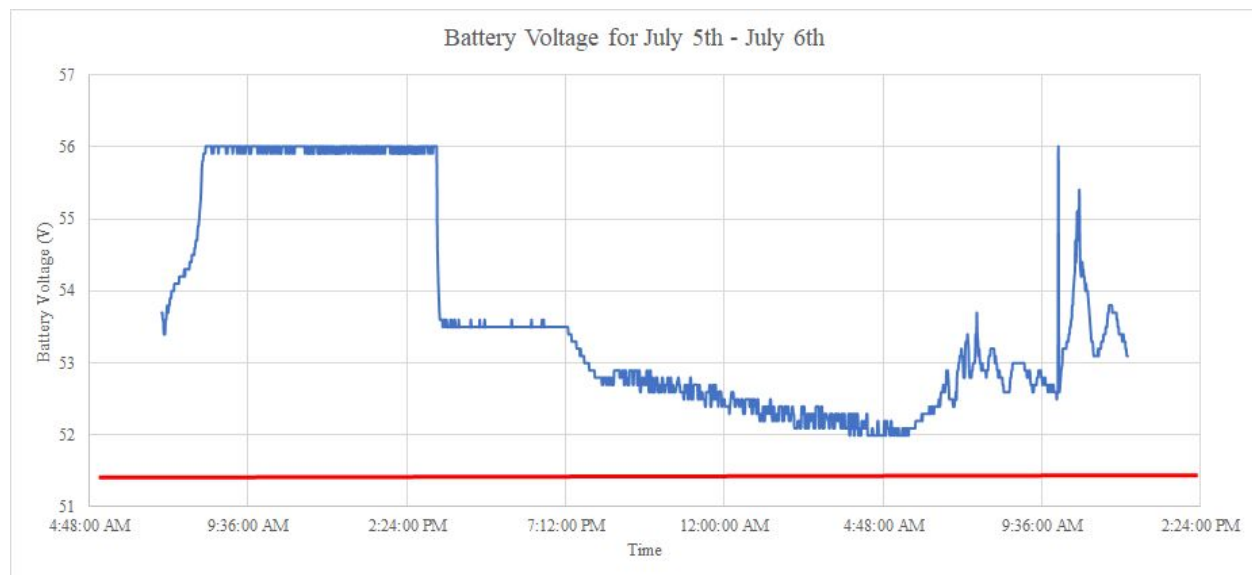
As predicted by the 2017 interns, the system from the MREU was able to power the salt water pump through the night. The lowest voltage that the batteries got to was 52V, so still 0.8V off from having to be switched over. On the graph this low voltage threshold is shown with a red line.

Figure 4: Battery Voltage for when the K-House System was kept on all night

The batteries started to be charged again around 5:30am, verifying that the system successfully powered the saltwater pump through the night. This also was the first night that the generator did not turn on. Since the batteries were drained throughout the night, the voltage in the morning was lower than normal. The day after, July 6th, the batteries did not become fully charged; however it was stormy, so there was not much solar to begin with.

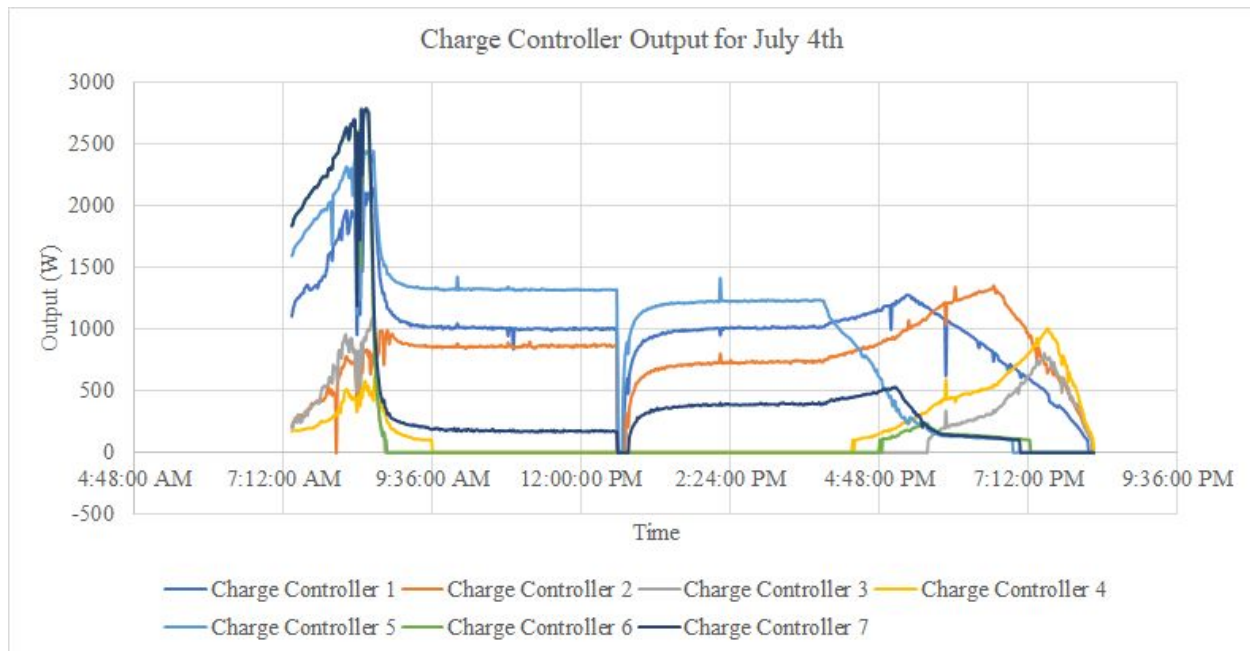
Each charge controller was graphed to show the difference between the outputs at different times per day. Two ideal solar days were analyzed.

Figure 5: Plot of Output for the numbered Charge Controllers for July 4th

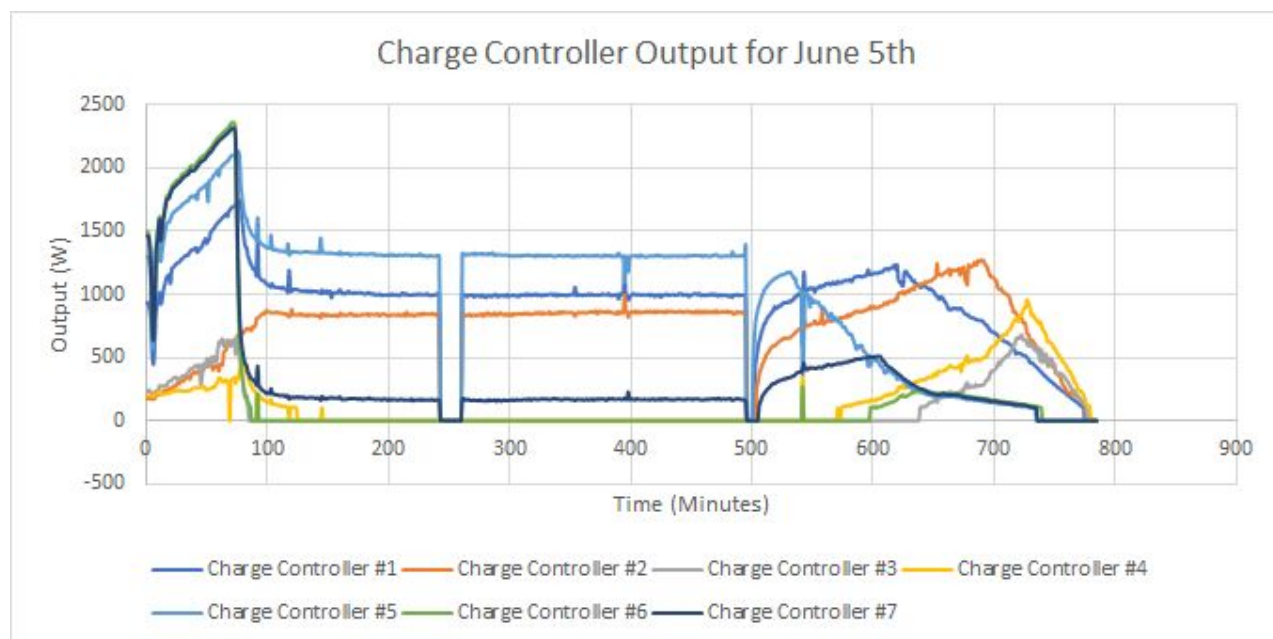
Figure 6: Plot of Output for the numbered Charge Controllers for June 5th

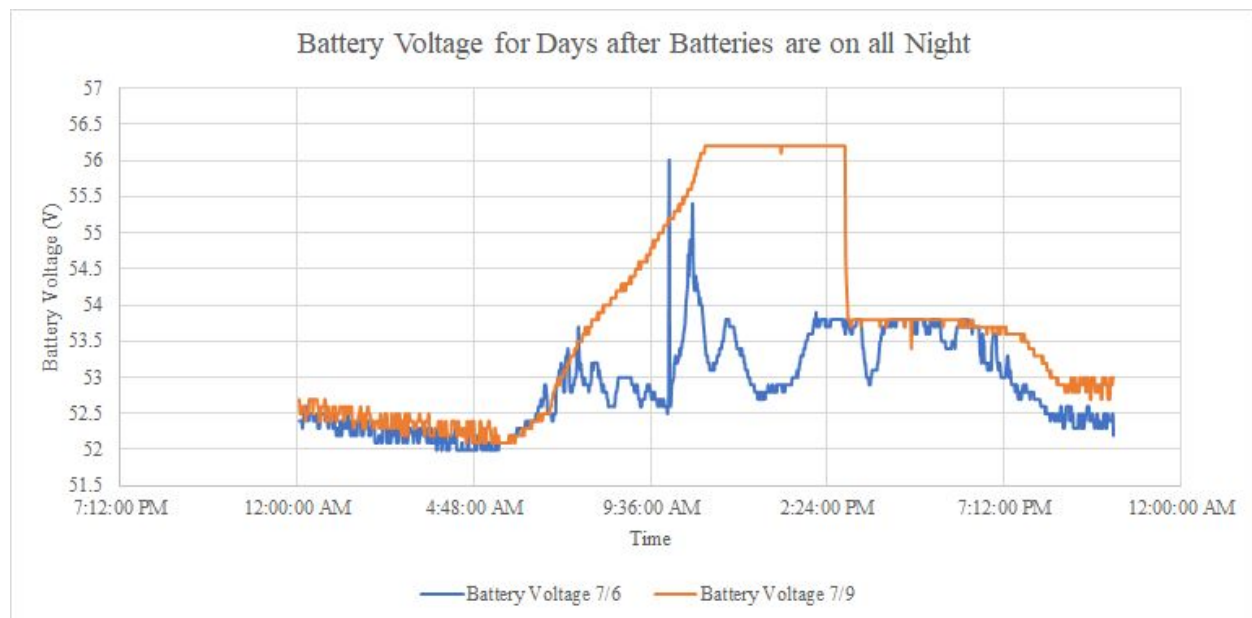
Utilizing the two days that the K-House system was left on all night, the interns can determine if the batteries get fully charged during the next day. The interns observed the two days after each all nighter, July 6th and July 9th.

Figure 7: Comparison of the Battery Voltages the day after being utilized all night

On July 6th the batteries did not get fully charged after being drawn out to 52.1V. The total energy from the solar panels was 60.56 kWh.

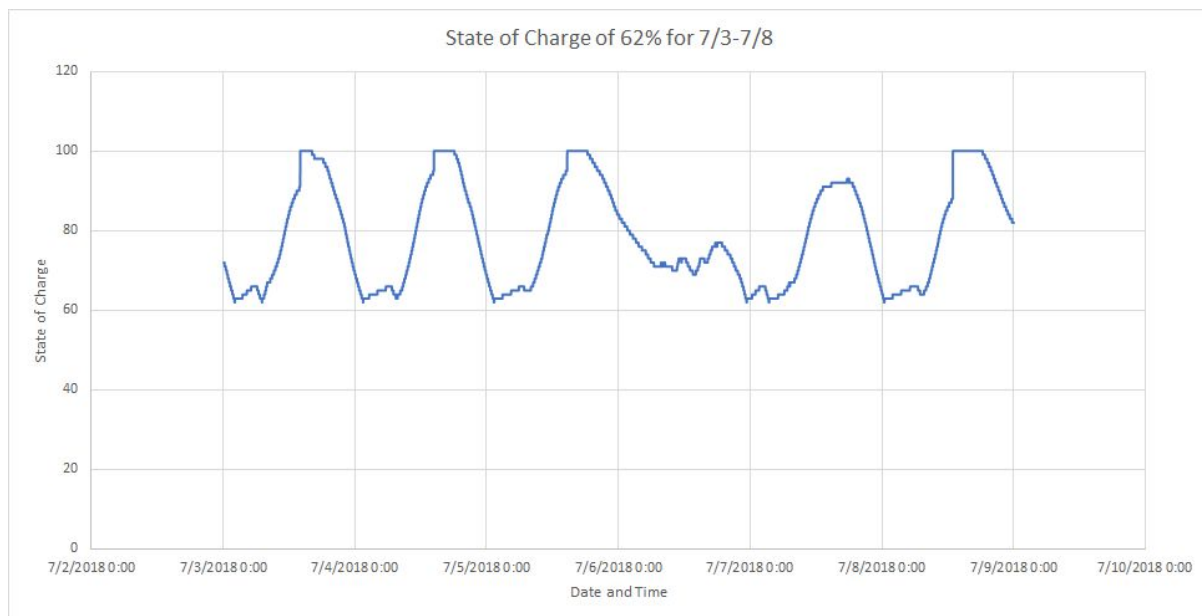
Theoretically, the larger the depth of discharge, the fewer cycles per day there should be; however, this is not reflected in the data. This may be because of several reasons, the first is this data was the smallest, at only a week. The second is that this data was also when the MREU system was being tested, this meant the MREU system was kept on for the whole night. This lessened the load on the island grid, which caused the batteries to power the island throughout the night. This week of data is shown below.

Figure 8: State of Charge for July 3rd to 9th at a Start SOC of 62% and Stop SOC of 67%

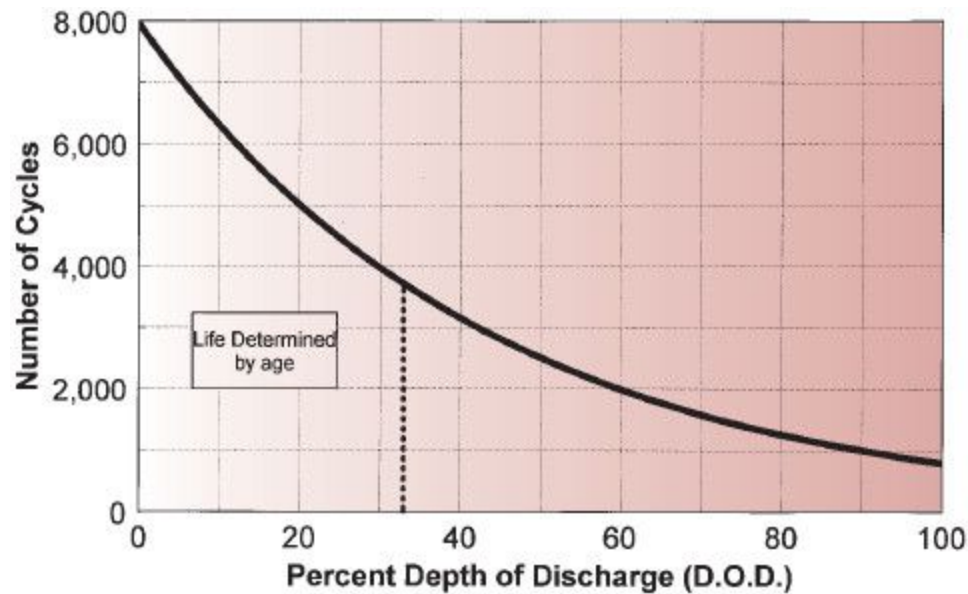
To calculate the lifespan left on the batteries, the interns need to know not only know the cycles per day, but also how many cycles these AGM batteries have at certain DODs. A graph comparing the DOD to the battery lifespan was found from the battery's company, Absolyte.

Figure 9: Lifespan related to Depth of Discharge

To calculate the seasons left, the cycles left were divided by the number of cycles per day and the number of days in a season. 150 days a season was used as a safe estimate.

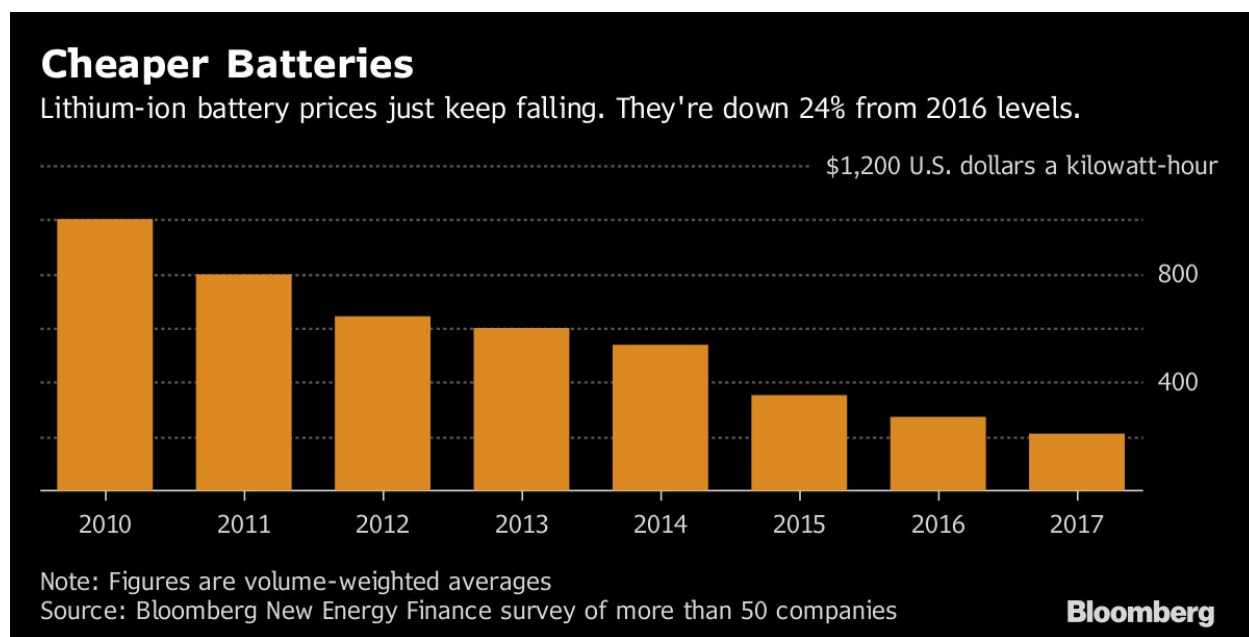
The current ECB lead acid batteries cost Shoals \$100,000; however, lithium ion batteries are also getting cheaper. The current cost for a kWh is \$209, and it is projected to get even cheaper, according to Bloomberg New Energy Finance Analyst, James Frith. The AGM batteries in the ECB is 300 kWh, which would be \$62,700 if they were replaced with Lithium Batteries. In the below chart, the smallest decrease in cost was 7%.

Figure 10: Decline in Cost of Lithium Ion Batteries. Graph from a Bloomberg New Energy Finance survey

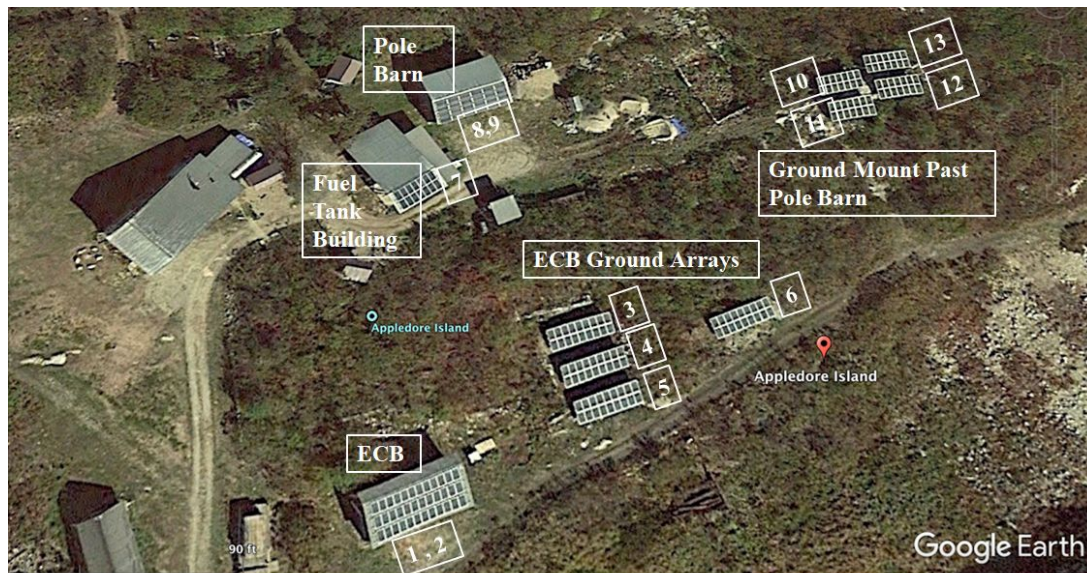
Since the interns needed to work with over 90 kW of solar panels, they mapped out all of the ground and roof arrays to keep track. A naming convention was also created for the southern based arrays as it was hard to keep track of the 13 arrays. These arrays were named corresponding to its charge controller. A schematic is represented below.

Figure 11: Layout and Numbering of the Northern Solar Arrays

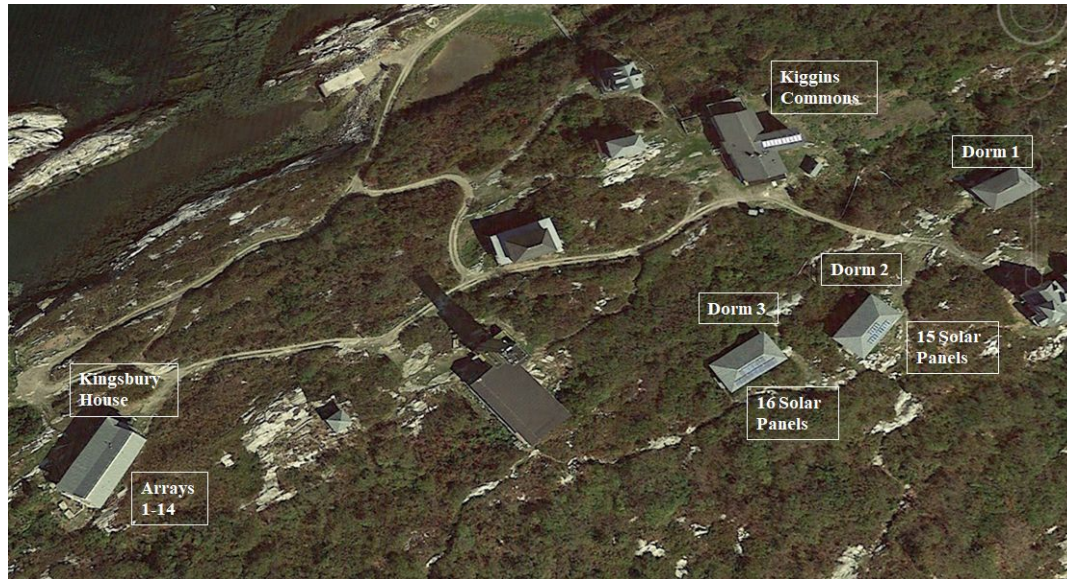
The arrays in the southern part of the island did not have the same ease of naming style, as the dorm panels are connected to the radar tower, and the Kingsbury House has its own system. The solar panels were counted on the dorms, and for K-House, the panels were identified the same way as the others. Each pair of the 14 arrays correspond to its own charge controller.

Figure 12: Layout of Southern Solar Arrays

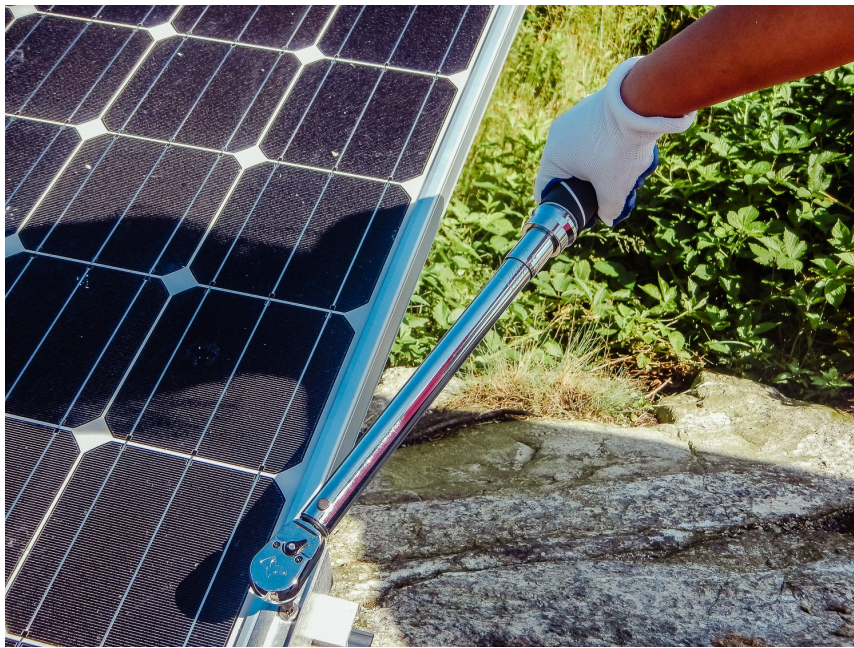
Another big part of maintenance is checking the bolts on the arrays and the wiring. The interns used a torque wrench to tighten the screws. Arrays 3-6 and 10-13 all had dry bolts which needed to be tightened to 10.5 foot-pounds. The torque wrench was calibrated to this exact value, and automatically clicked when the 10.5 ft-lb force was reached. The ground arrays were the only arrays where the bolts were tightened, since there is not as safe a footing on the roof arrays. Arrays 10-13 are higher up than arrays 3-6, so the interns used a ladder; however, the interns were unable to reach the second row from the top of the ground arrays past the pole barn.

Figure 13: Tightening Bolts

The ground arrays' conditions haven't been checked since 2014 installation. A torque wrench was used to tighten the dry bolts on the ground arrays. Most of the bolts on the arrays by the ECB needed a few turns to tighten, which was looser than expected. A ladder was utilized to reach the higher bolts. The bolts on the ground mount arrays past the pole barn needed much less tightening. Although many were at the recommended torque value to begin with, there were also

some bolts that needed tightening. The distribution between tight and loose bolts was random, so the interns checked all the bolts that they could safely reach. This loosening was probably caused by vibration caused by wind and by tightening the dry bolts, it helps lessen the friction between parts that might reduce efficiency.

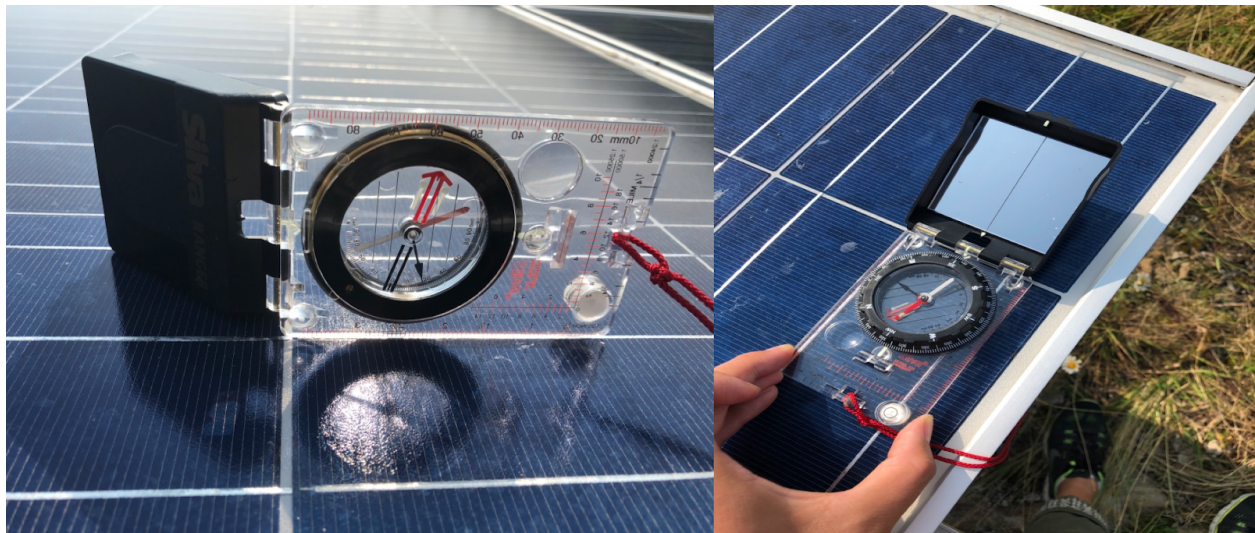
In order to capture the maximum amount of solar radiance, the amount of tilt is approximately the latitude angle of the site facing 15 degrees due South. Empirically, if the tilt angle of the solar arrays is within 15% of the latitude angle, a 5% or less reduction in annual power output can be achieved. The interns used a Silva compass to measure the tilt angles of the solar arrays to see if the solar arrays are tilted to reach their best performance. When laying the compass on its side directly against the solar panels, the dip angle can be read from the clinometer. The interns took direct measurements on the ground mounted solar panels. Similarly, the exact positions of the ground mounted solar arrays can be measured by placing the Silva compass directly on the panels and measure the plunge angle. The roof mounted ones can be estimated by positioning the compass approximately to the direction they are facing and take several readings to minimize the uncertainty.

Figure 14: Tilt Angle (left) measured as Dip; Array Position (right) measured as Plunge

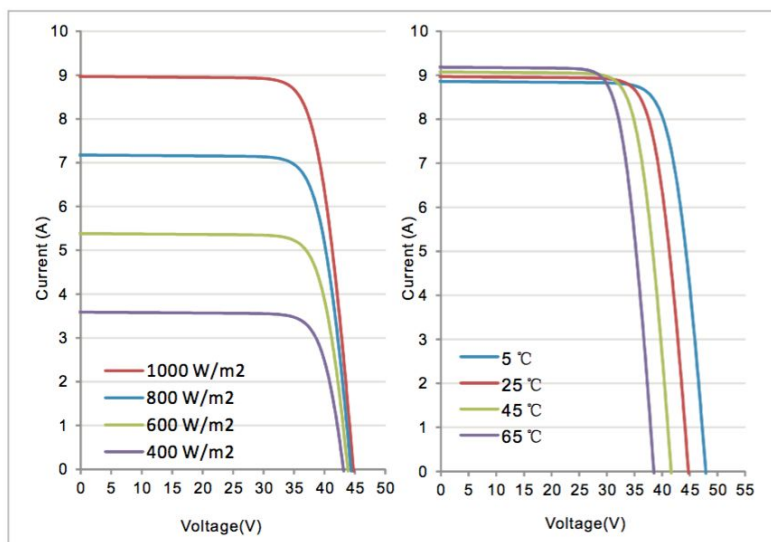
CS6X-305P | I-V CURVES

Figure 15. Example I-V Load Curves for CanadianSolar--CS6X 305P.

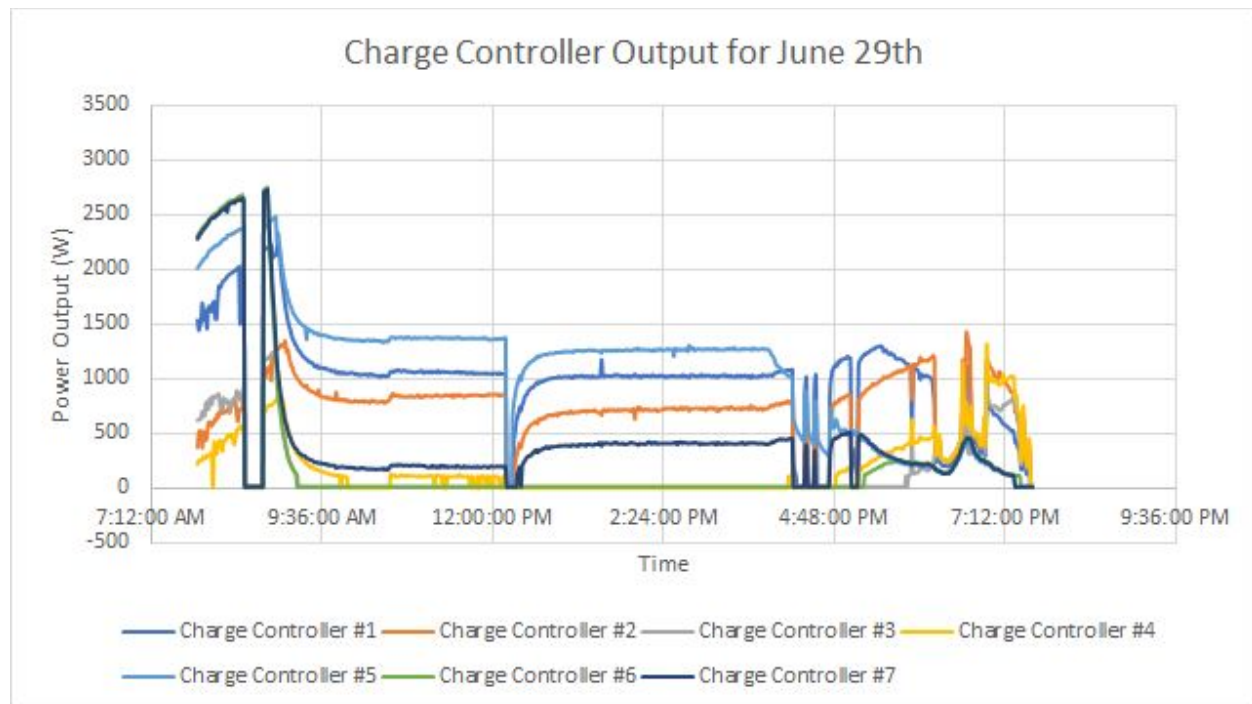
Figure 16: Graph for each Charge Controller of K-House for June 29th

The interns took these measurements on June 29th at around 11:30 for K-House. At this point, charge controller #6 is producing 0W; however at about 8am it was producing the most wattage. This means the orientation of charge controller #6 is most efficient in the early morning, and not when the interns measured it. Charge controllers 1, 2, 3 and 4 are connected to solar panels on the NW, with 4 connected to panels at a lower angle. They generally perform best in the late afternoon and early evening. Charge controllers 5, 6 and 7 are connected to solar panels on the roof facing SE, and perform best early in the morning. This is exactly the intention of installation in the first place, trying to spread out the peak performance time throughout the day.

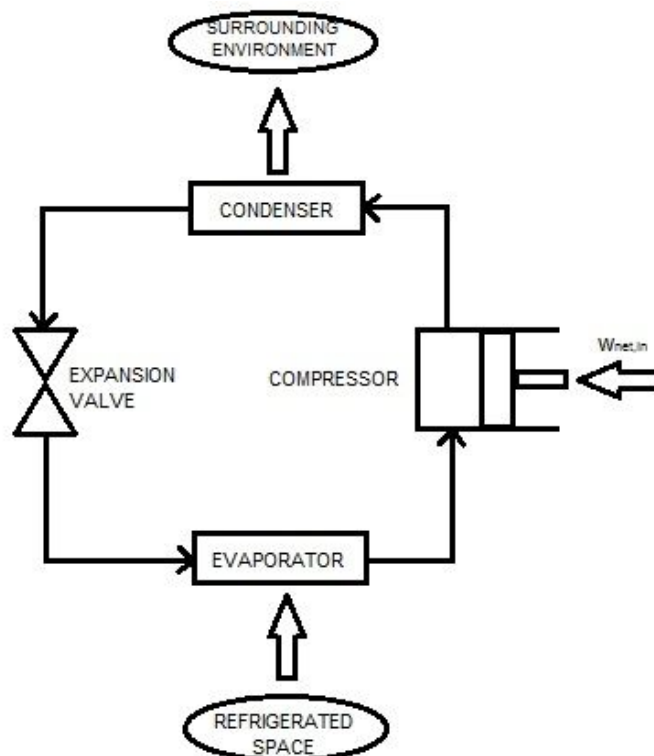
Typical refrigerator system operates by extracting or rejecting heat to a refrigerant going through multiple phase changes. A simple illustration of this process is shown in figure 17. Arrows 1, 2, and 3 represent the heat absorbed by the refrigerant, heat rejected to the outside, and the work input to operate the compressors, respectively.

Figure 17: Representation of how a Refrigeration System Works

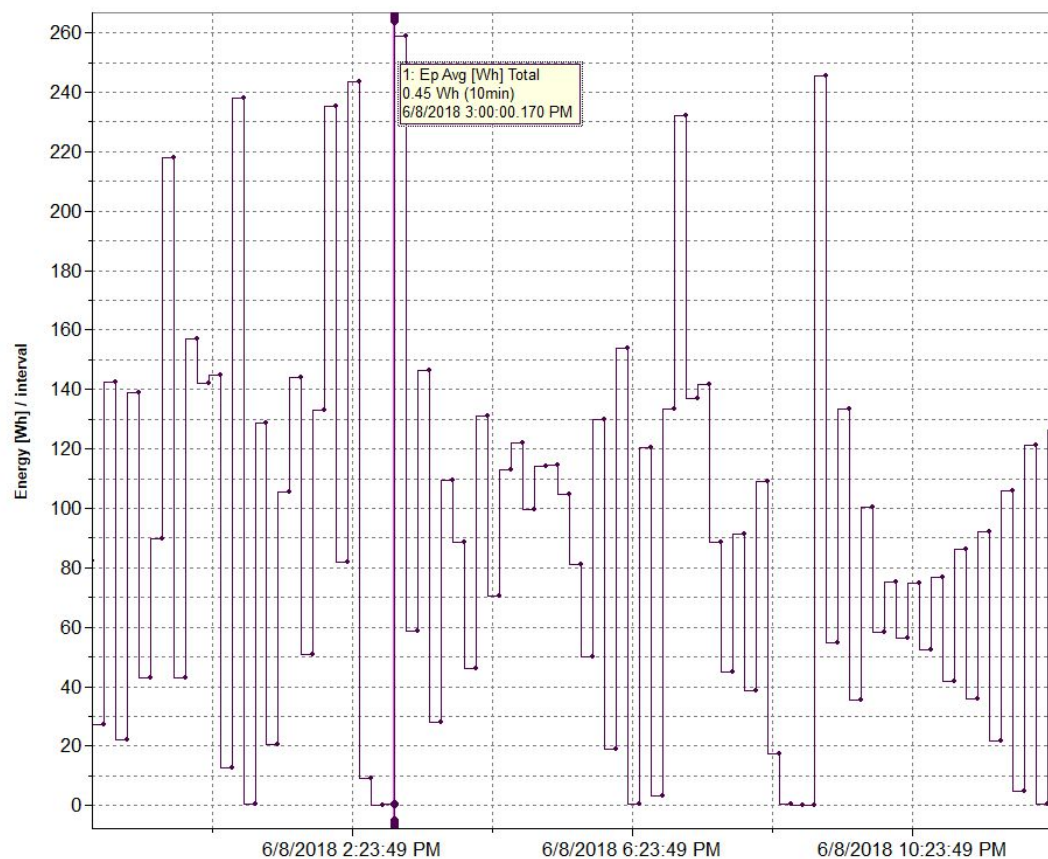
The average island load is about 270 kWh, so the whole fridge/freezer system makes up about 14% of the island's load.

Figure 18: Graph of Energy Consumption of the Fridge Compressor over several Hours

Justin Ulrich from Unitil came to help the interns understand the fridge data. He said the since the data was varied, characterized by the significant variance in figure 18, it meant the power coming in from the generator was not in phase with the compressor motor. A variable frequency device (VFD) can be used to correct for this.

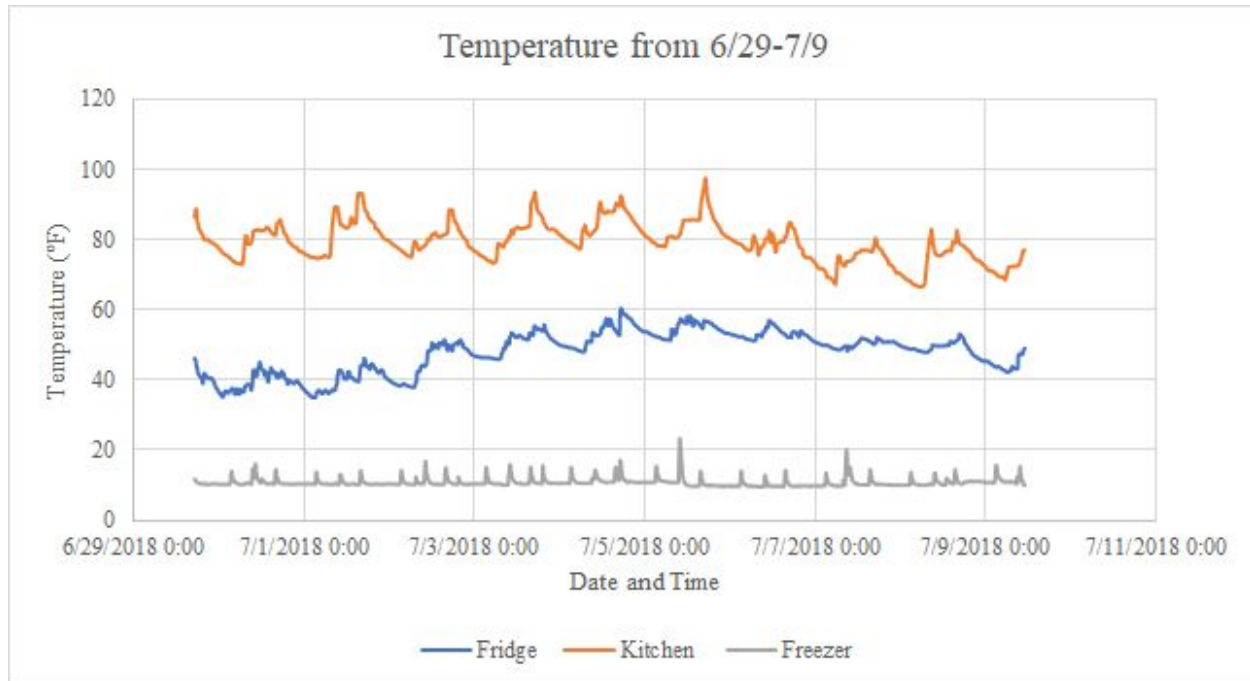
The temperature of the kitchen, fridge, and freezer was recorded over several days. If temperature changes too often, it could be indicative of cold air escaping from the inside. Figure 19 shows the temperature changes over a ten day span.

Figure 19: Temperatures for Kitchen, Fridge, and Freezer

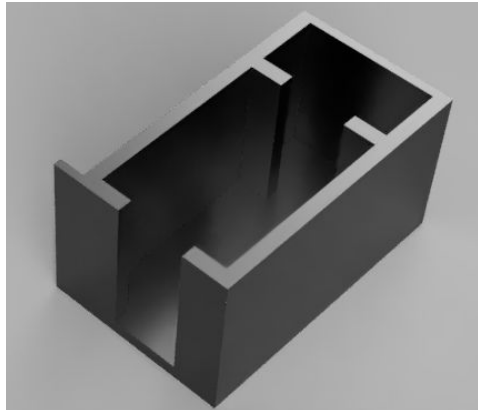
The refrigerator system was measured, and a CAD of the system was made.

Figure 20: CAD of the Refrigerator and Freezer System

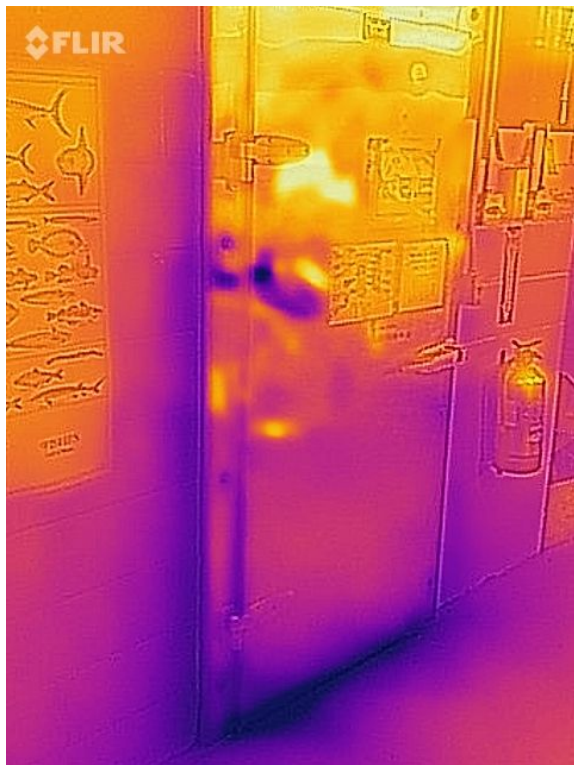
Since the refrigerator system is over 40 years old, there are many components that are growing old, negatively affecting heat retention and efficiency. When the fridge system was first examined, there were several aspects that immediately needed attention. The gasket, the rubber seam ensuring no heat would enter through the cracks in the door, had holes and was starting to disintegrate. The outer edge of the fridge door accumulates condensation on a regular basis and freezer door gets stuck because of ice buildup. These issues indicate that the seals on both doors are failing.

Figure 21: IR Picture showing Cold Seeping under the Door

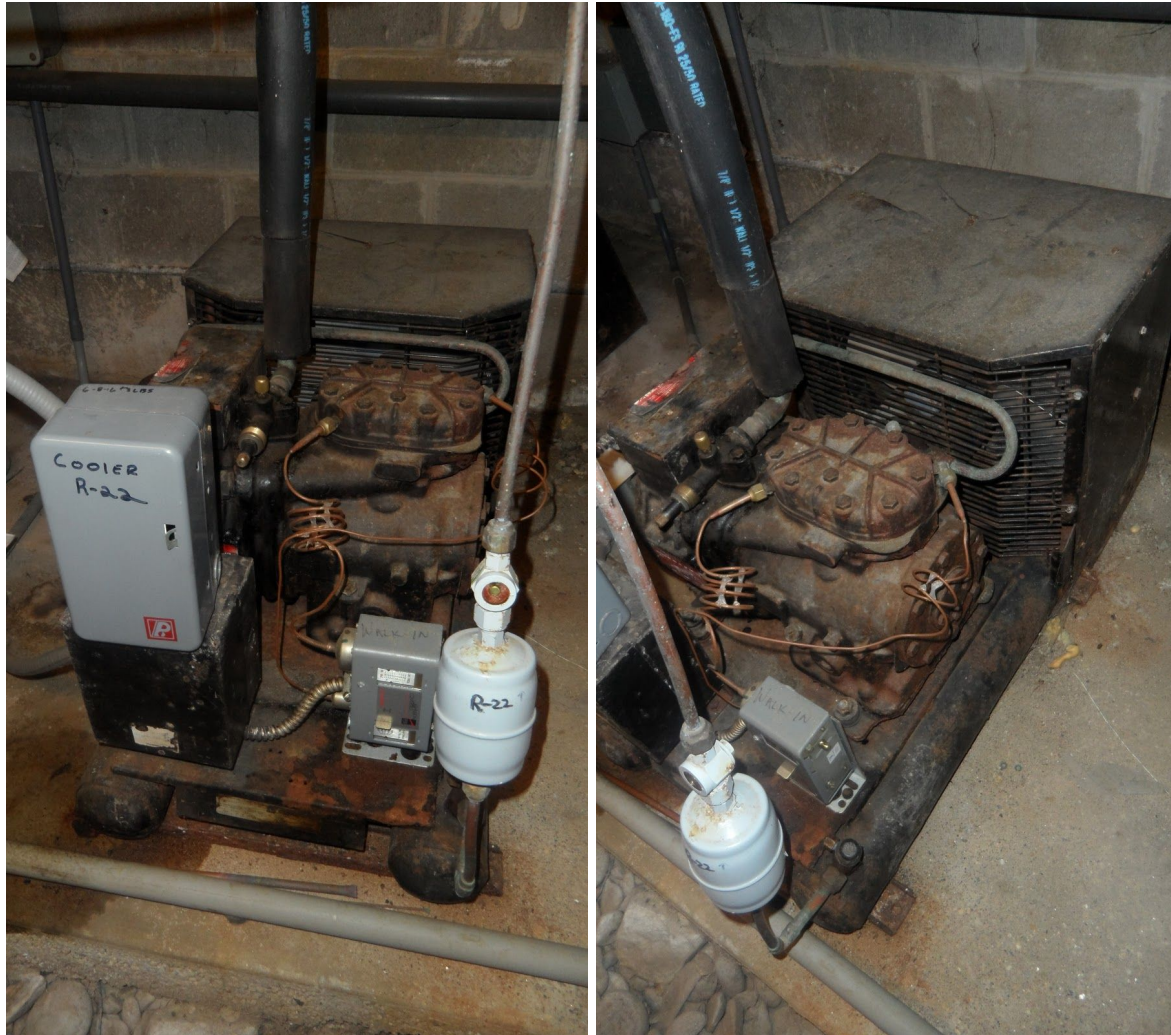
Another replaceable component is the compressor system. Though the specific date of installation is unknown, island staff say that the system has not been renewed since the original date of installation back in the mid 1970's. This is not too surprising, as both the fridge and freezer compressors show signs of extensive wear; figure 22 shows the state of the fridge compressor. One would expect a 40-year-old compressor to be failing in all sorts of ways, but with a few replacement parts installed over the past few years, including the refrigerant for the freezer, there seem to be no blatant performance issues. Interns originally thought that the coefficient of performance could be calculated, but ended up learning that this value could only be determined in a highly controlled lab environment. For this reason, analysis of the compressors is based off of observation alone, so further testing could be done if SML wishes to know true thermodynamic performance.

Figure 22: Refrigerator Compressors

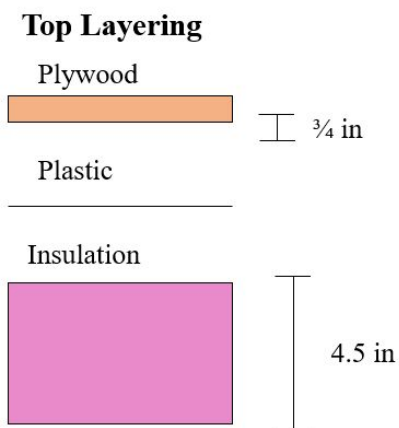
The insulation is a two part urethane foam, which surrounds the system. On the top side, there is insulation, a plastic layer, and a piece of plywood. The left and right sides have insulation and a concrete masonry unit (CMU). The back is just a large CMU. The front side is a metal door, and CMUs.

Figure 23: A Layout of the Top Wall

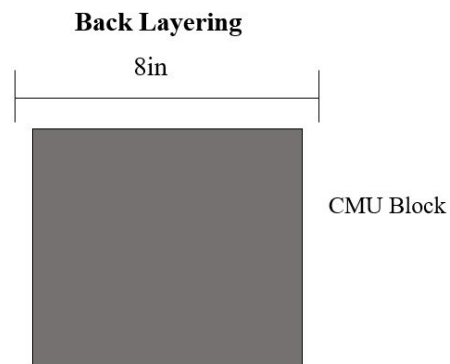
Figure 24: A Layout of the Back Wall

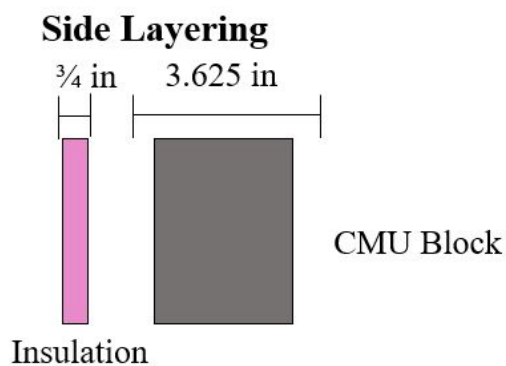
Figure 25: A Layout of the Side Walls

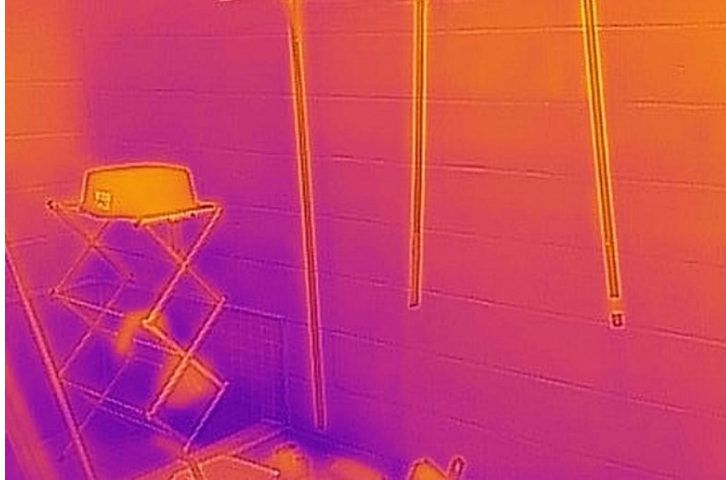
The fridge and freezer on the walls represent the distinction between where the fridge ends and the freezer starts. Tom Johnson lended interns a thermal imaging device to show the temperature gradient on the outside wall of the fridge and freezer. Dark purple represents lower temperature heat seepage from the freezer.

Figure 26: Infrared Picture of Left Outside Wall of System

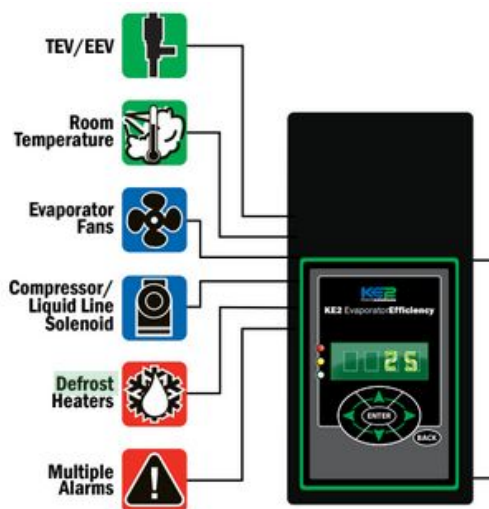
Ross Hansen introduced the interns to the company KE2Therm, which has already been implemented in some of Cornell's refrigeration systems, saving the university thousands of dollars in energy cost. KE2Therm was contacted, and a webinar information session was set up. The KE2 Evaporator Efficiency was determined to be the best option for SML. It is a "smart" system that controllers heating, temperature, fan cycles, compressor runtime, and demand defrosts. It can be installed on the fridge wall, the evaporator fans, or outside the fridge door. Although placing it on the fridge door is not the best place for a commercial kitchen.

Figure 27: KE2Therm Evaporator Efficiency Device

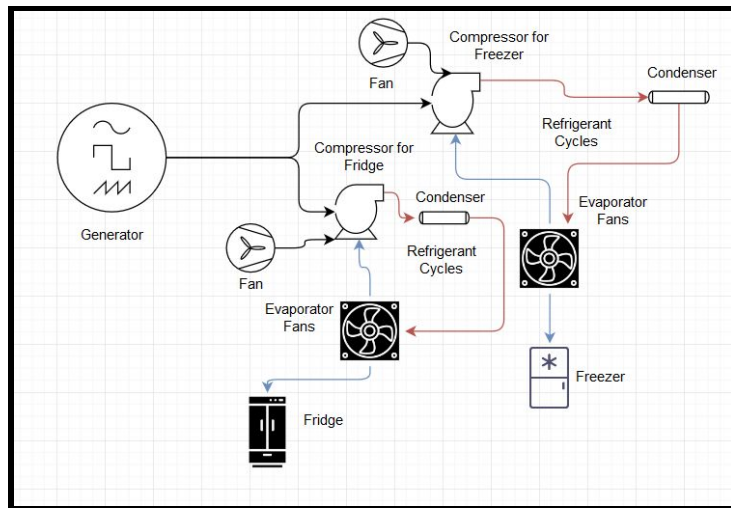
Figure 28: Representation of how the Refrigerator System Operates

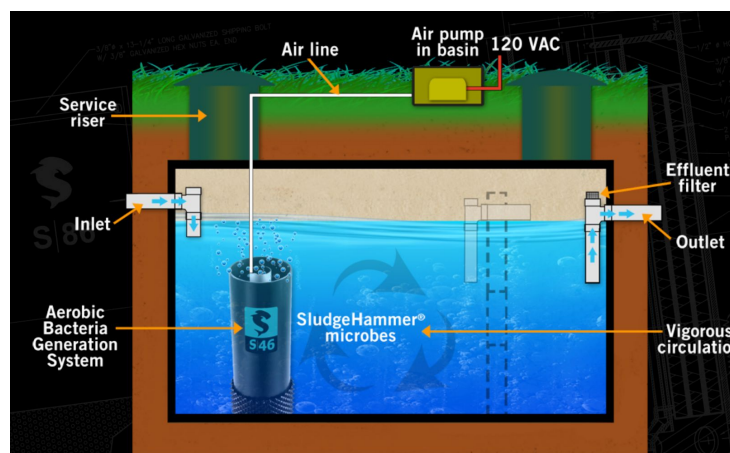
Prior to the installation, interns met with the New England distributor of SludgeHammer products, Gregory Teren. This meeting provided the interns with a better idea of how the system operates. A basic schematic of the system is shown in figure 30, taken from the SludgeHammer website.

Figure 30: Schematic of the SludgeHammer System

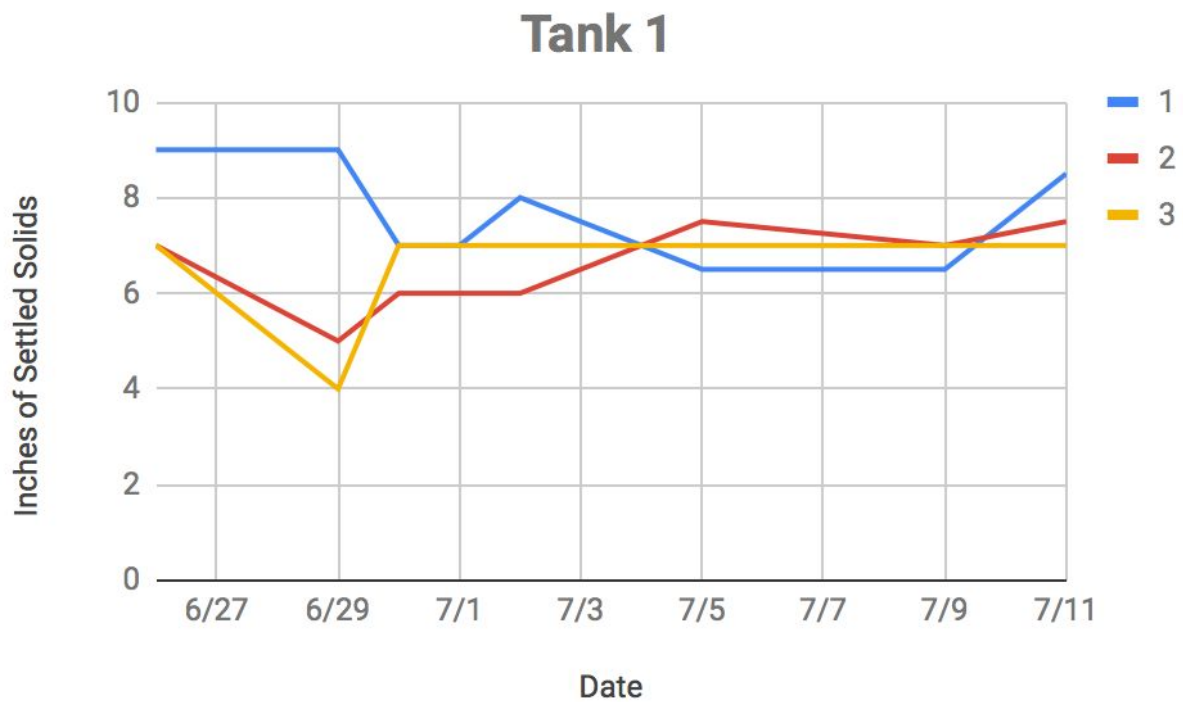
The depth of solids were monitored in the following weeks to analyze how the SludgeHammer affected the initial sludge depths throughout the tanks. As can be seen in Figures X and Y below, the sludge depths in tank one were minimal. A reduction in 2-3" was seen initially in tank 1, however, this was due to the solids being mixed into a more homogenous slurry. These solids included both the scum on top, which was broken up only a couple days after installation (excluding the scum before the first baffle near the inlet streams), as well as the sludge on the bottom which became agitated due to the aeration. After the initial agitation of tank 1, these suspended solids began to settle again as can be seen in the plateauing depth of solids. Another major factor which influenced this data was the release of the plastic filter in tank 1. Due to the heavy agitation in tank 1 due to mixing and aeration, the heavily turbid slurry clogged the filter between the two tanks. It was recommended by Dr. Wickham and Dr. Kinner to remove the filter entirely to allow flow to the second tank. This removal caused a rapid flow of heavily turbid wastewater to move into tank 2. This equilibration that occurred brought a large amount of suspended solids into tank 2, which then settled and caused an increase in sludge depth. Sludge depths in tank 2 increased significantly from 2"-3" before installation to upwards of 10".

Figure 31: Sludge Depths in Tank 1
