Sustainable Engineering Internship

2018 Final Report

Jacob Shactman, Gabby Peralta, Laurel He, Takeru Nishi

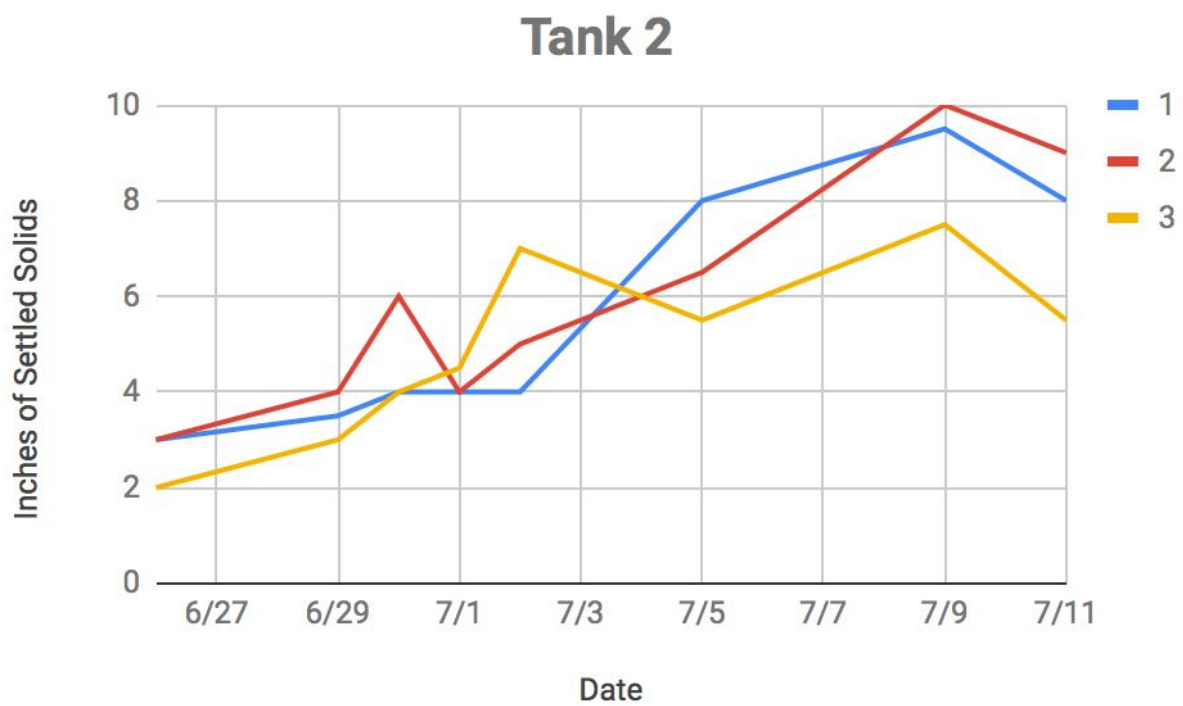
The depth of solids were monitored in the following weeks to analyze how the SludgeHammer affected the initial sludge depths throughout the tanks. As can be seen in Figures X and Y below, the sludge depths in tank one were minimal. A reduction in 2-3" was seen initially in tank 1, however, this was due to the solids being mixed into a more homogenous slurry. These solids included both the scum on top, which was broken up only a couple days after installation (excluding the scum before the first baffle near the inlet streams), as well as the sludge on the bottom which became agitated due to the aeration. After the initial agitation of tank 1, these suspended solids began to settle again as can be seen in the plateauing depth of solids. Another major factor which influenced this data was the release of the plastic filter in tank 1. Due to the heavy agitation in tank 1 due to mixing and aeration, the heavily turbid slurry clogged the filter between the two tanks. It was recommended by Dr. Wickham and Dr. Kinner to remove the filter entirely to allow flow to the second tank. This removal caused a rapid flow of heavily turbid wastewater to move into tank 2. This equilibration that occurred brought a large amount of suspended solids into tank 2, which then settled and caused an increase in sludge depth. Sludge depths in tank 2 increased significantly from 2"-3" before installation to upwards of 10".

Figure 32: Sludge Depths in Tank 2

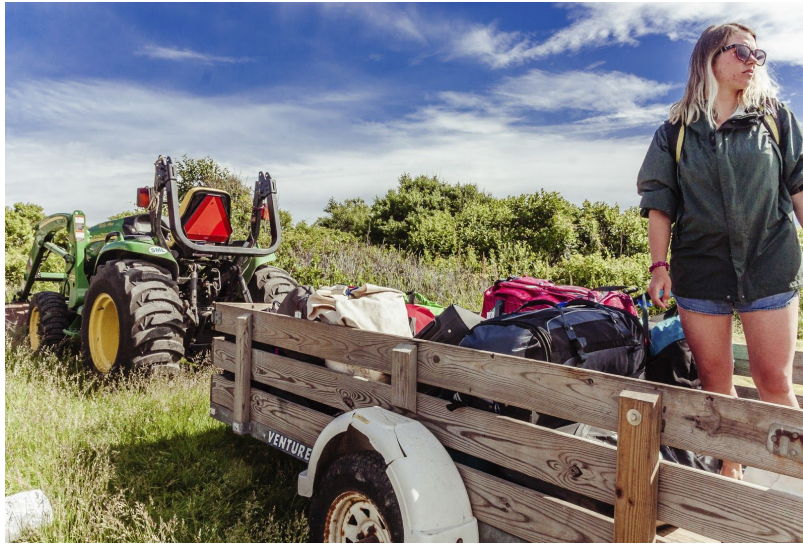
Figure 33: Single axle trailer being pulled by the tractor

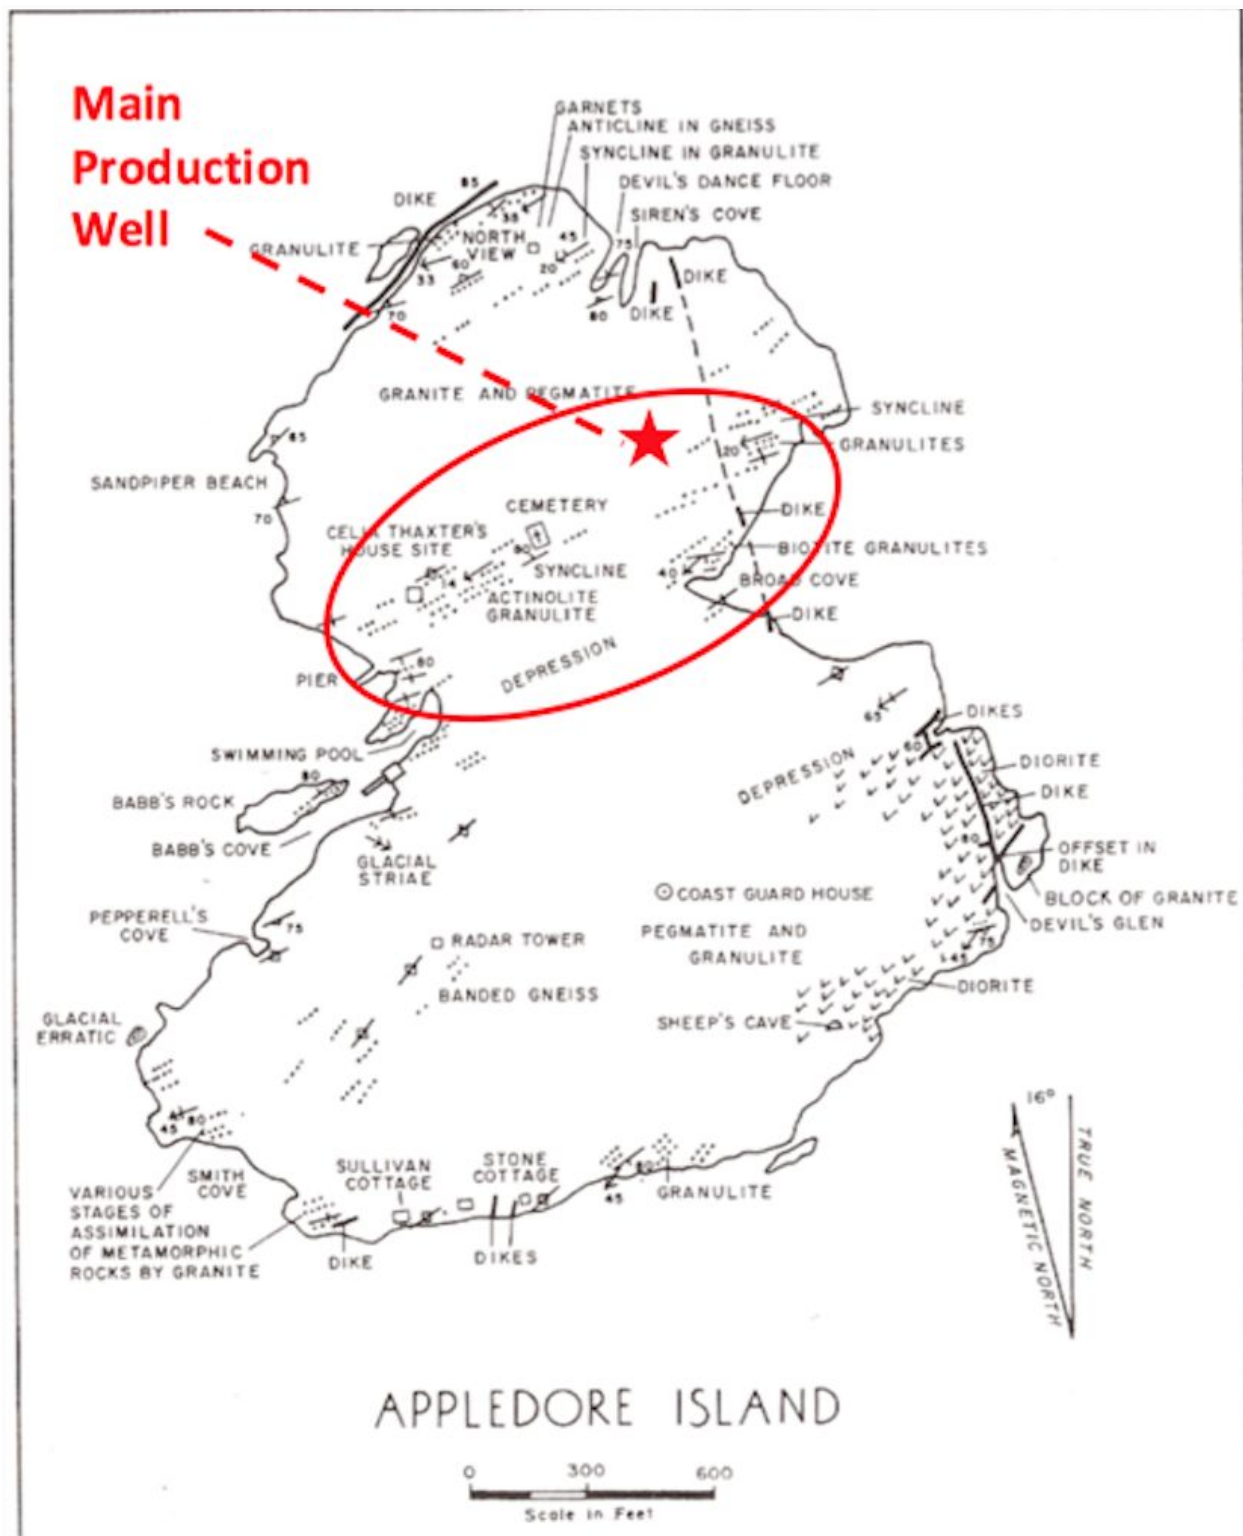
The interns researched the geological background of Appledore Island to have a better understanding of the freshwater aquifer. The island is composed of igneous rocks, mostly dark colored diorite with light colored granite intrusions, overlain by metamorphic rocks such as schist, gneiss and granulite, extending throughout the islands appearing as bedrock outcrops. Because the metamorphic rocks erode more easily than the surrounding granites, they form depression between the northern and southern part of the island. Folding occurs in the metamorphic rocks, creating synclines. The size and scale of the local synclines are unknown, but the syncline and the depressions are places that are filled with sediments, such as sand, gravel and silt, and have capacity to store water. Both the syncline and the depressions are in the East West direction on the Northern part of the island. The location of the wells basically follow this E-W oriented line where the aquifer formed. During excavations near the Main Well, the aquifer was found to be composed of a poorly-sorted mixture of grain sizes.

Figure 38. Map of Appledore Island with important geologic features.

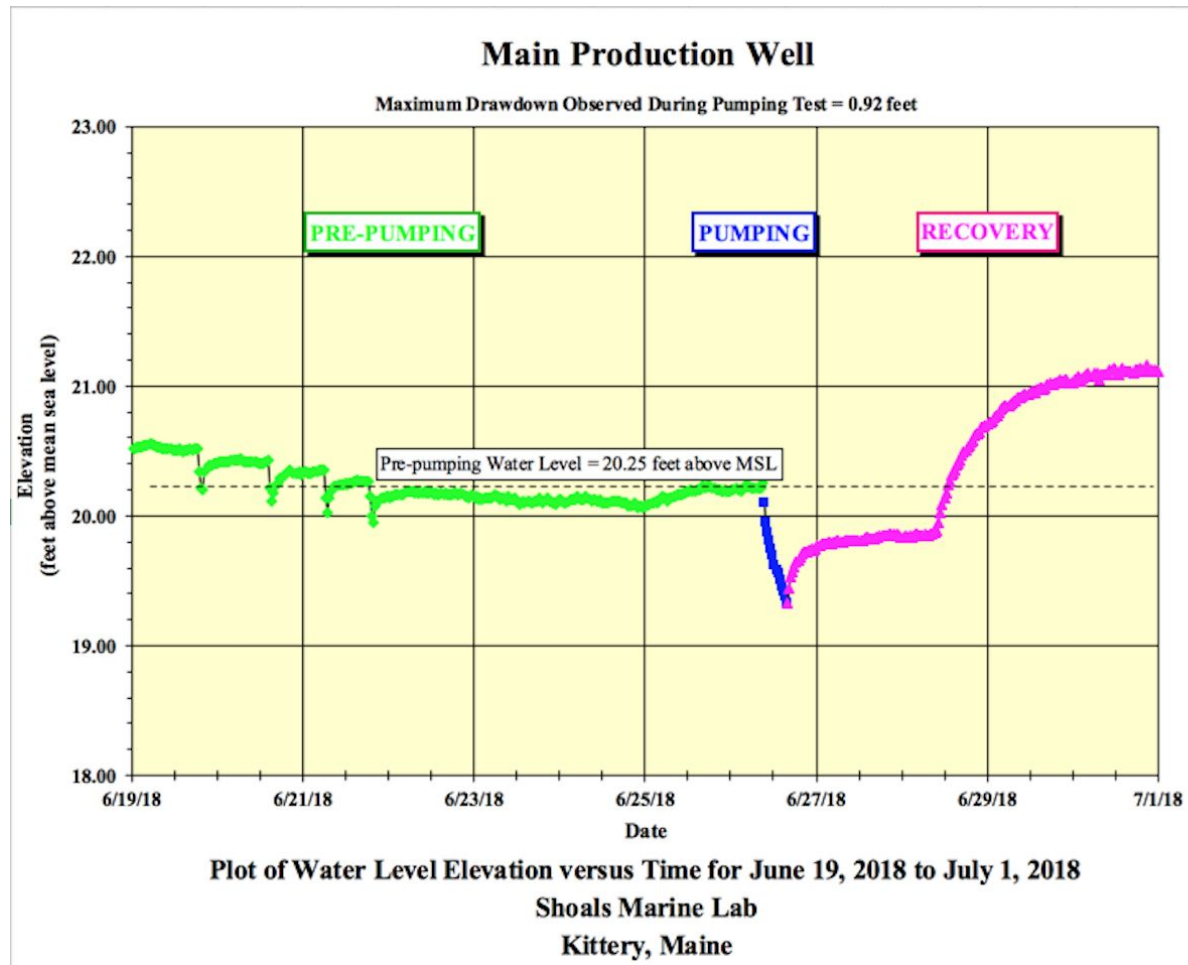
Figure 39: Main Production Well Pumping Test

The green section of the curve indicates water level changes before the pumping test. The small step decrease events were due to water usage and regular pumping out of the well. The blue section of the curve is the water level decrease during the well drawdown test. The magenta part is the recovery curve after pumping has stopped and water level was allowed to stabilize. The test was conducted on June 26th, and on the 29th a storm hit Appledore island. The fact that aquifer system is able to reach equilibrium fairly quickly (in the order of magnitude of hours), and that the water level responds immediately and increases drastically to a heavy rain event, indicates the aquifer is unconfined and limited in extent.

The well drawdown test aims to find hydraulic properties of the aquifer such as storage coefficient, transmissivity, and specific yield. Unfortunately, since the test wells are dry, the interns weren't able to obtain those values. Basically, only the main production well produced usable data, and the interns were able to draw some qualitative conclusions from these results.

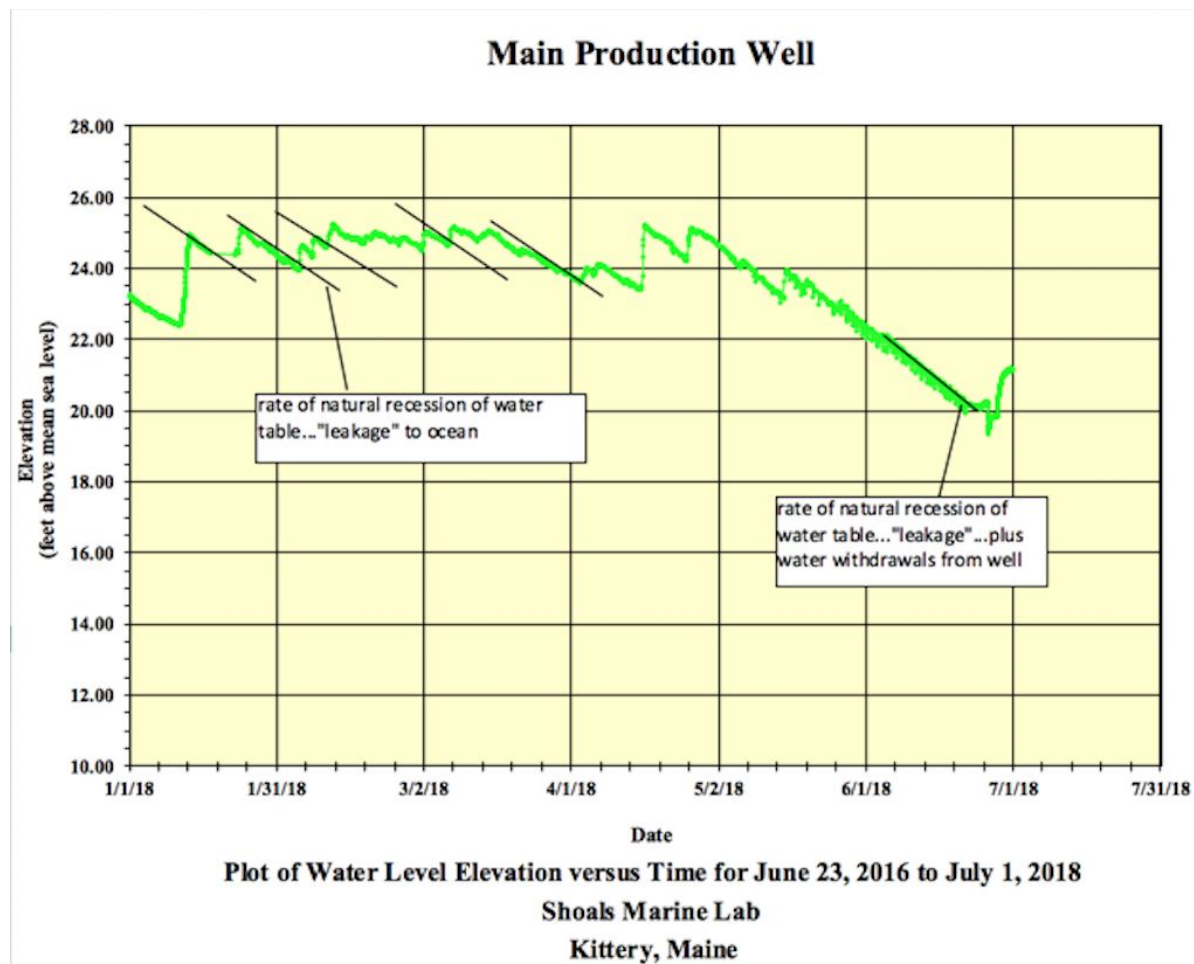
Figure 40: Main Production Well Water Level vs. Time (January - July 2018)

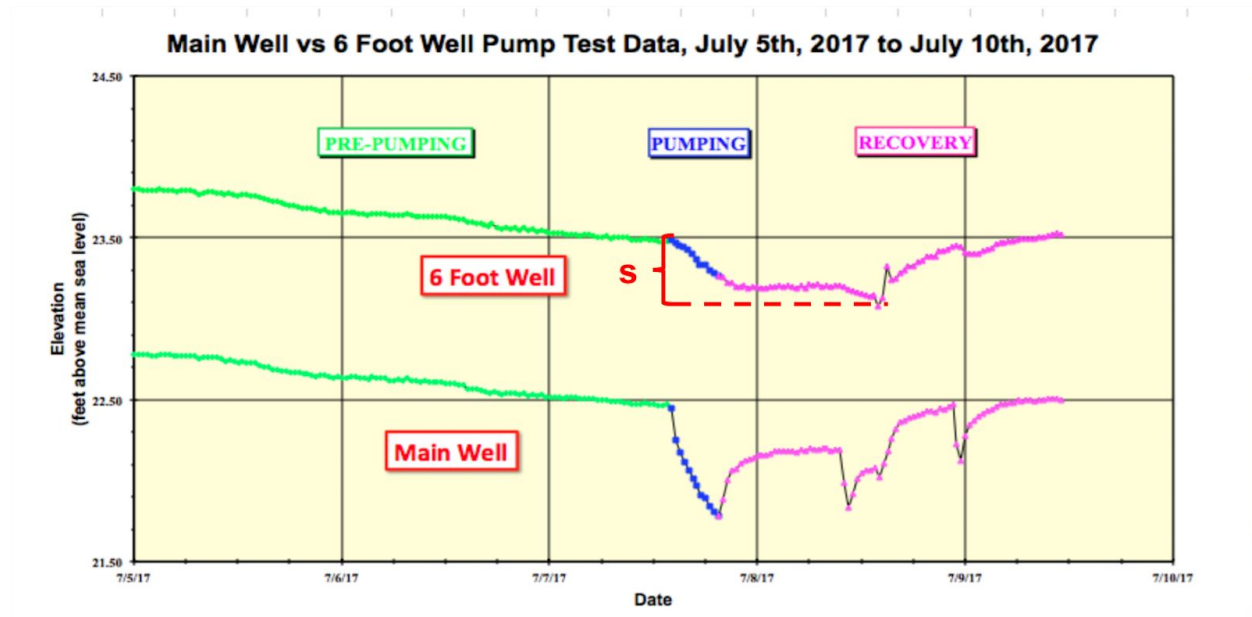
As stated, in order to find hydraulic properties of an aquifer, at least one other well is required in addition to the main well. Fortunately, the 2017 SEIs did a pumping test and the 6 foot test well wasn't dry. More accurate results could have been found using software analysis such as AQTESOLV, the interns this year didn't have enough time to get to such results and therefore used simpler models and hand calculations to approximate.

Figure 42. 2017 Pumping Test Result: Water Level Changes for Main Well and 6-foot Test Well
