# Sustainable Engineering Internship

*26 July 2015*

Chelsea Kimball, Dylan Masi, Susan McGrattan, Marisa Zellmer

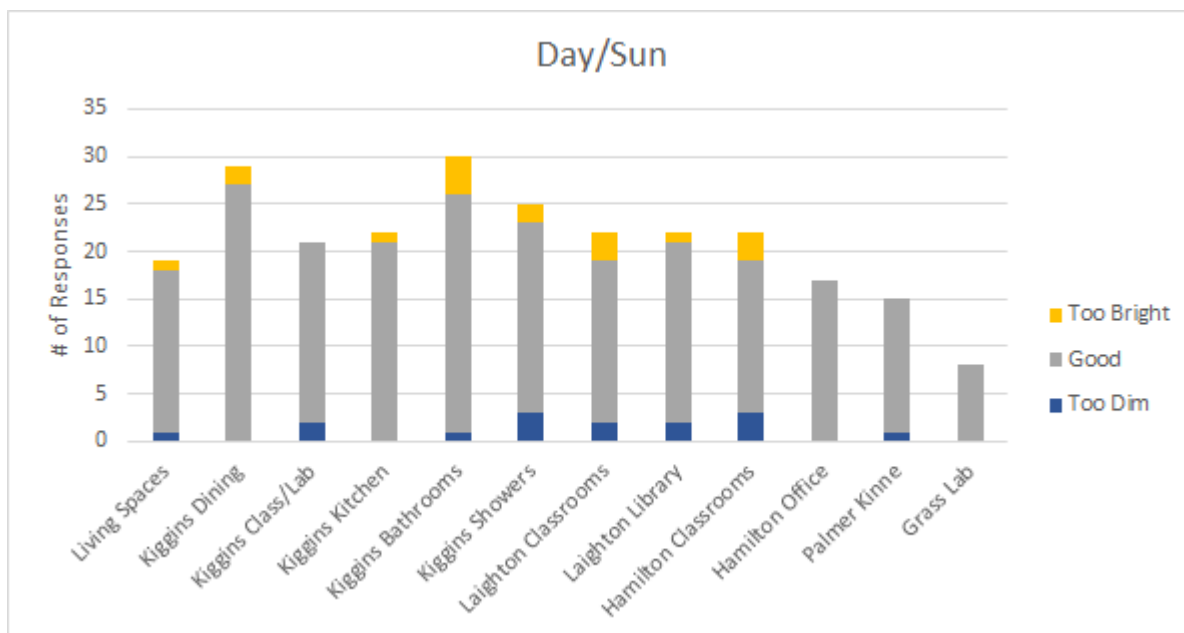
The majority of residents for each room replied that there was adequate lighting available. There were more “Too Bright” responses during the day and more “Too Dim” responses at night, which is to be expected because of sunlight levels. However, the number of “Good” responses was greater than the “Too Bright” and “Too Dim” responses combined for all buildings. As a result, it was determined that changes in light level were most likely unnecessary.

Figure 43: Daytime Lighting Quality Survey Responses

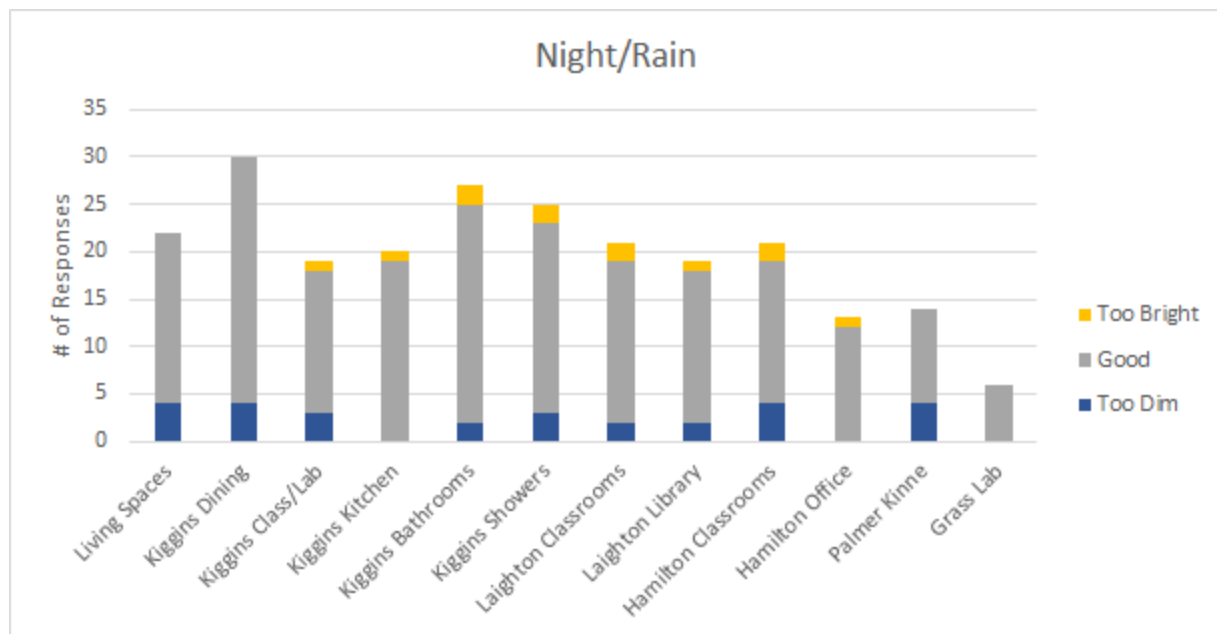
Figure 44: Nighttime and Rainy Day Lighting Quality Survey Responses

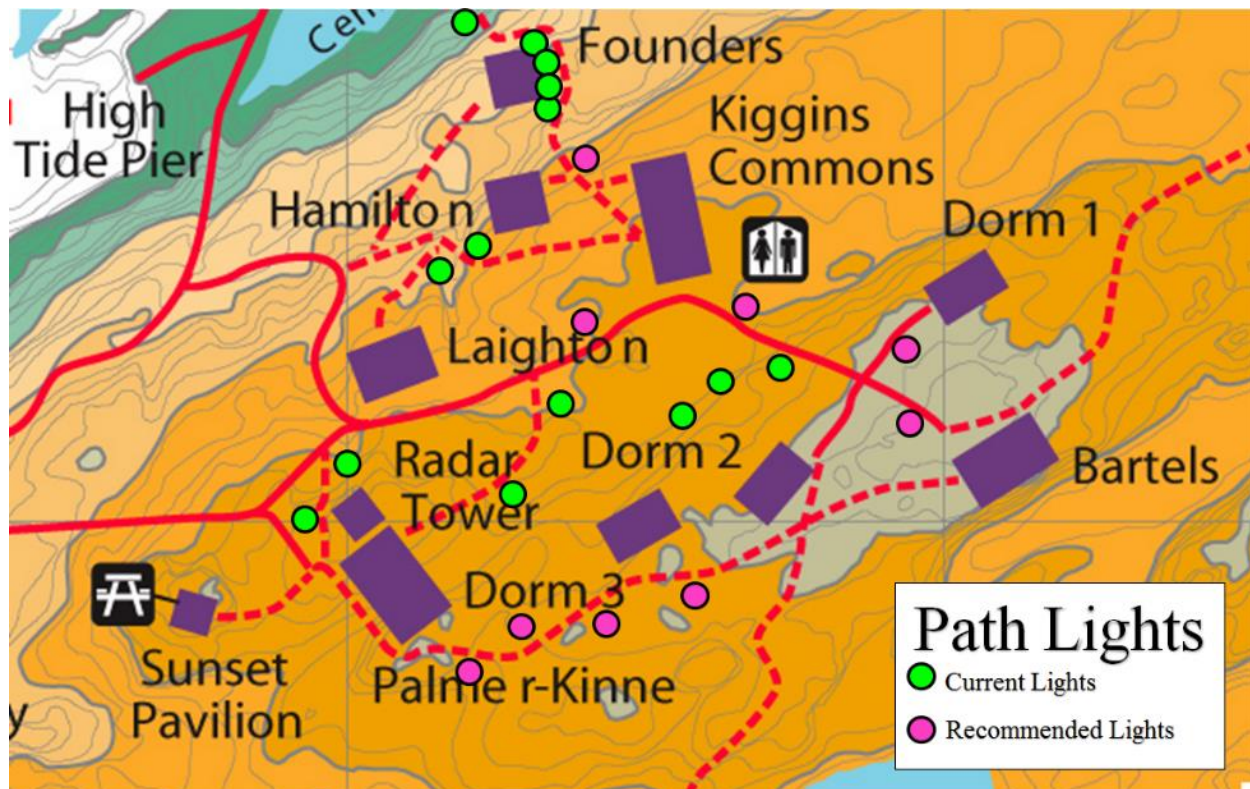
Nine outdoor path lights should be added to the current outdoor lighting path system to increase island resident safety when navigating the island at night. The locations of the added lights are shown in the below figure. A portable, LED, solar-powered path light is recommended; a set of ten can be purchased for approximately \$50. To reduce disturbance to wildlife on the island, red outdoor lights could be used instead of white lights. Red light has a lower impact on creating light pollution while still allowing critical visibility. Red lights may be more expensive, so this option should be explored more thoroughly. Outdoor lights on timers would significantly reduce the amount of energy used, so that the lights are not on when everyone on the island is asleep and not utilizing the pathways.

Figure 47: Outdoor Additional Pathway Lights

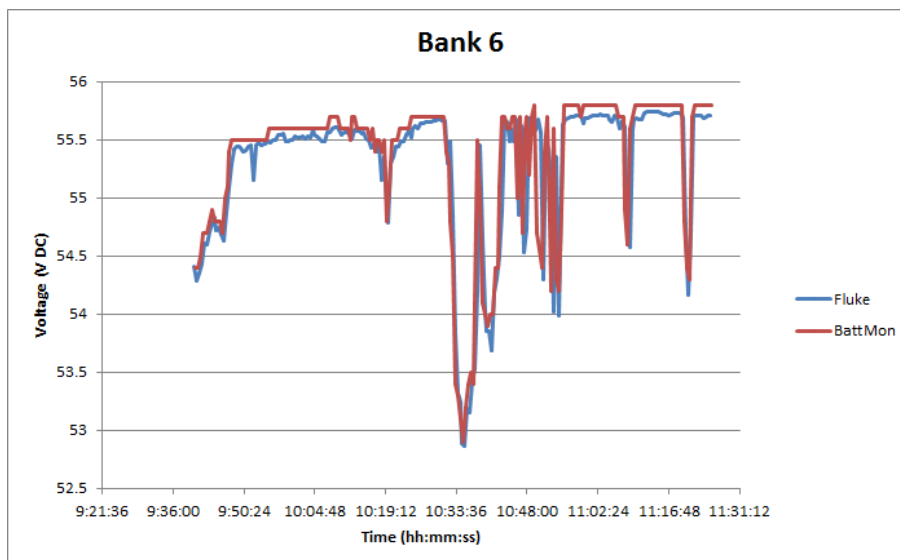
The current, in amperes, was measured with the fluke meter from all ten battery banks against the current measured with the battery monitor on Battery Bank 6. Two trials were done for measuring current to account for any error in case the meter had not been properly zeroed during the first round of trials. A third trial was conducted to measure the difference in voltage between the battery monitor and fluke meter in the ten battery banks to see if the voltage readings followed a similar pattern. Since the data for Battery Bank 6 matched up closely for both the fluke meter and the battery monitor during all three trials, the interns were able to assume that the fluke meter readings were comparable to the battery monitor readings.

Figure 48: Battery Bank 6 Voltage

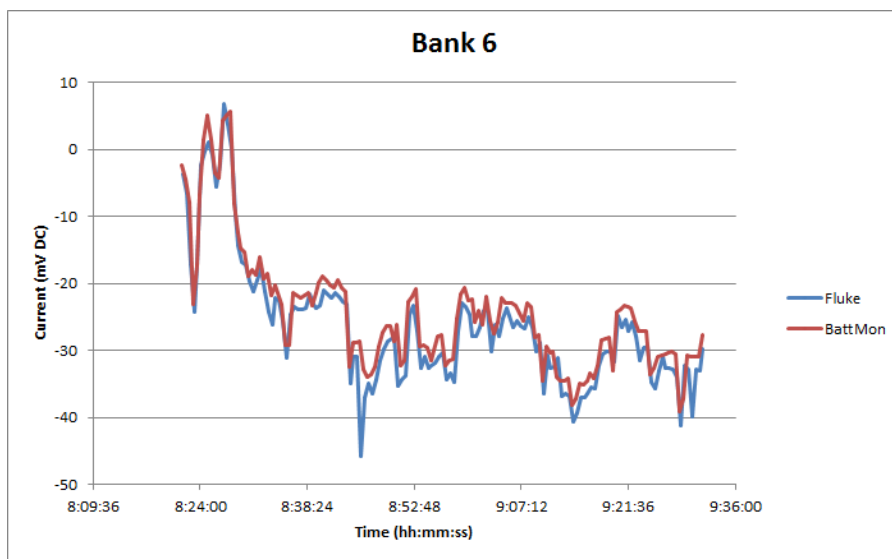
Figure 49: Battery Bank 6 Current

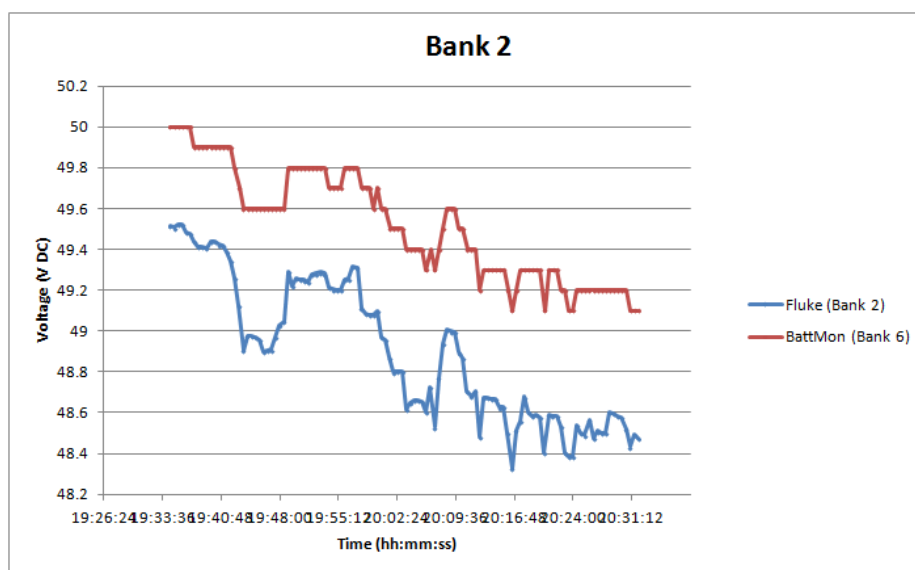
The three trials measuring current and voltage were repeated for each of the ten battery banks. Most of the readings from the banks appeared to match up well with Battery Bank 6's reading and follow the same trends. This was not true for all of the banks, however. For example, Battery Bank 2 was greatly offset from the readings on Battery Bank 6 in each of the current and voltage trials. The interns later analyzed the differences between the readings on Battery Bank 6 and the other banks to determine any outliers. The graphs below show the comparison between the readings on Battery Bank 2 and Battery Bank 6.

Figure 50: Battery Bank 2 Voltage

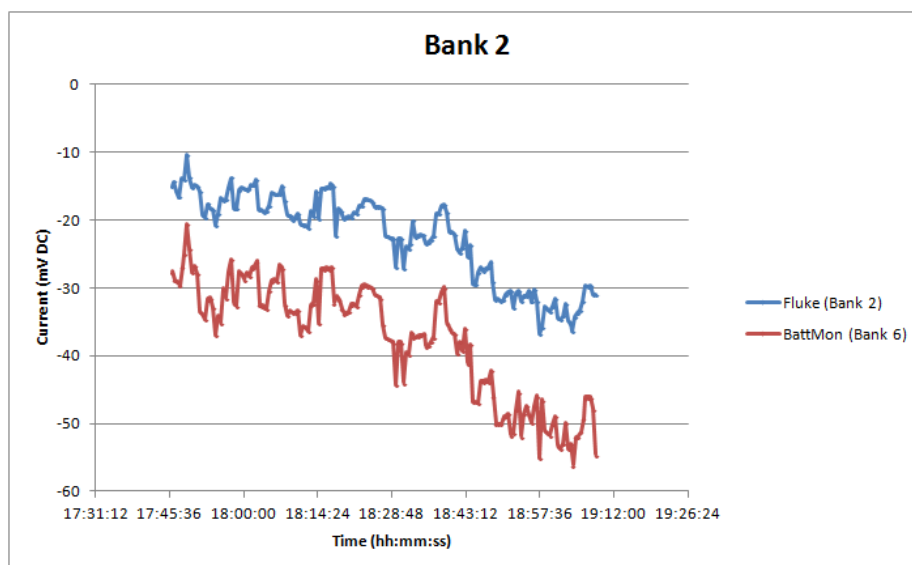
Figure 51: Battery Bank 2 Current

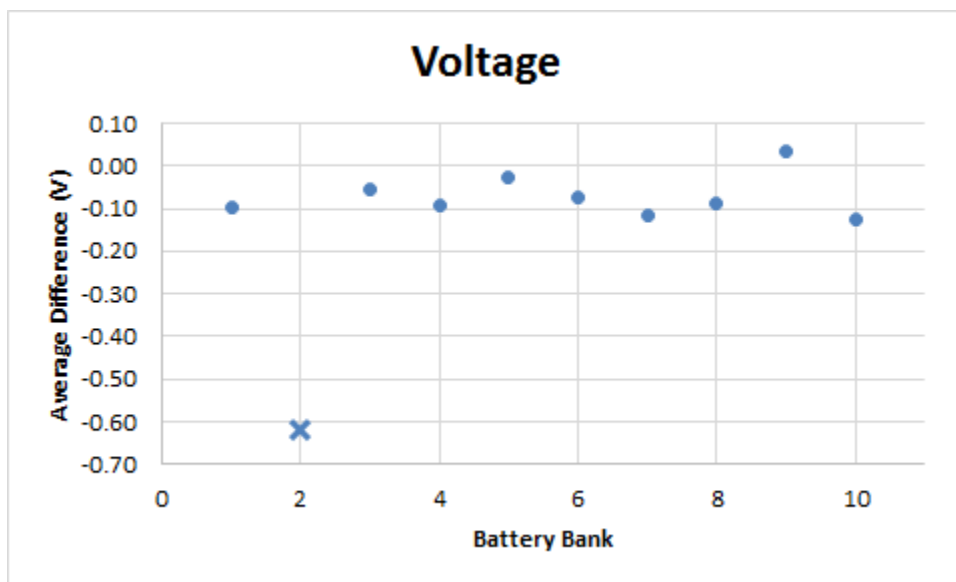
Based on these average differences tables, the interns noted that Battery Bank 2 and Battery Bank 9 may not be charging and discharging the same as Battery Bank 6 because the average differences were much higher than those of the other banks. The interns confirmed this by performing an outlier calculation to determine which banks, if any, should be looked into for efficiency. It was found that Battery Bank 2 was an outlier for all three trials and Battery Bank 9 was an outlier for one of the current trials.

Figure 52: Voltage Average Differences

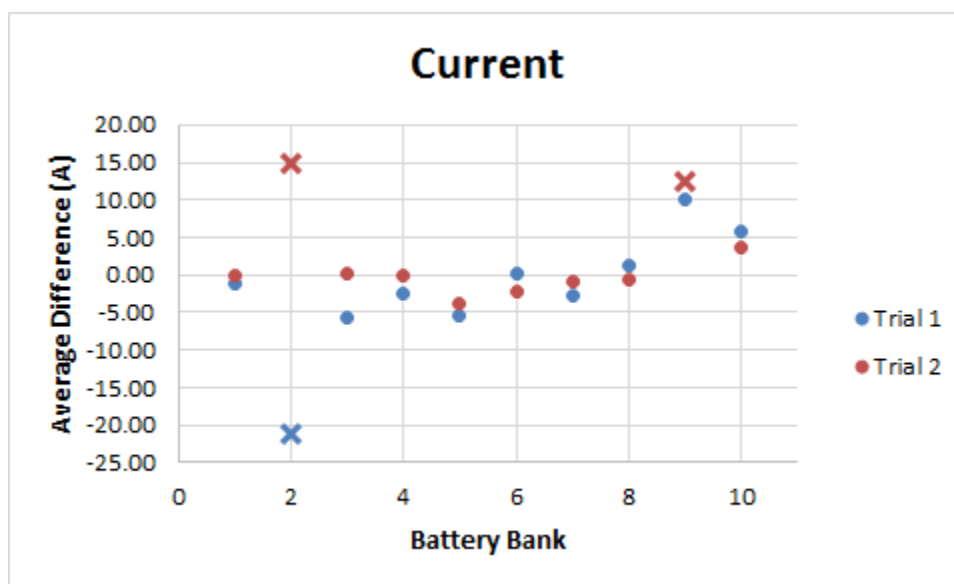
Figure 53: Current Average Differences

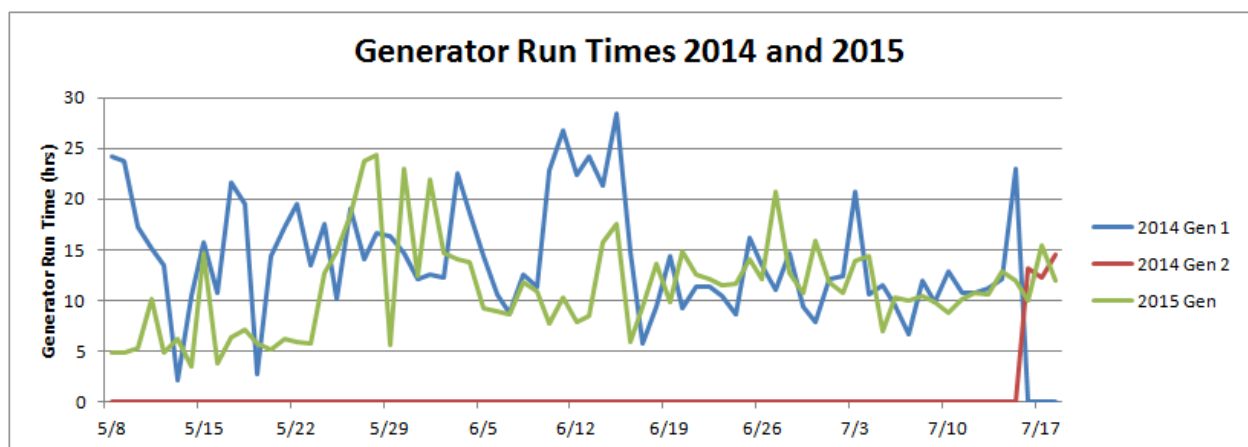
The graph comparing generator run times in 2014 to 2015 showed that the generator typically ran fewer hours per day in 2015 than 2014. This was to be expected as the 55 kW solar array was not completely installed until early July in 2015. The data for 2014 generator run times included large spikes, especially in May and early June. Island engineers confirmed that this was due to the fact that the ECB was just being installed at this point, and the staff were still working on figuring the system out. During this time, the depth of discharge of the batteries was not set at a constant level, and technical issues with the new system caused occasional blackouts and brownouts that led to the generator running a full 24-hour period. Some of the values in the graph are above 24 hours because the generator logbooks are not always recorded at the same time each morning and night.

Figure 54: Generator Run Times 2014 and 2015

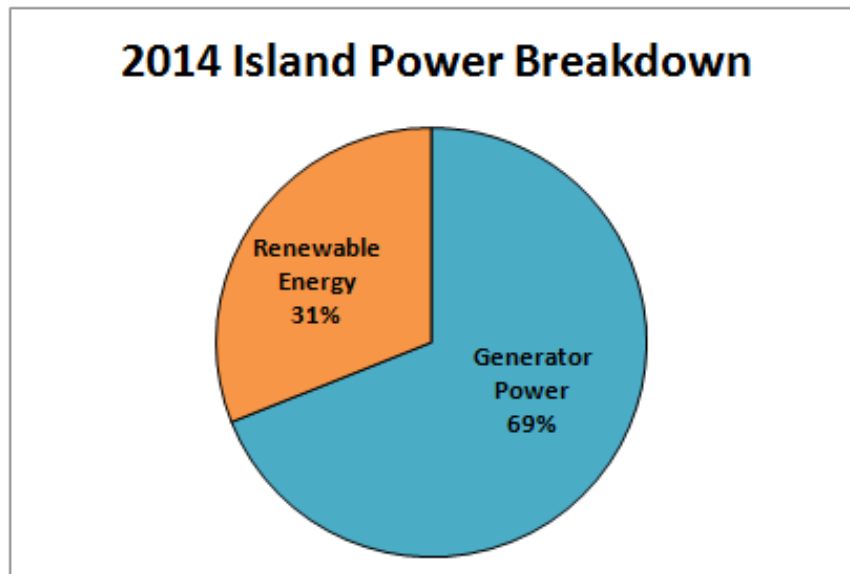
Using information from the generator power logs and the total island power logs from 2014 and 2015, the interns looked at how the installation of the 55 kW solar array affected the percentage of island power that came from the generator. It is important to note that the power from the old green grid is not included in this data, which makes it appear that the renewable energy makes up a smaller fraction of the total power than it actually does. The power percentages were found on both a monthly breakdown and over the total measured time. The percentage of power supplied by the generator decreased from 2014 to 2015 in each of the months that were evaluated. As shown in the two pie charts, the summer of 2015 has shown a 6% decrease in power coming from the generator compared to 2014.

Figure 55: 2014 Island Power Breakdown

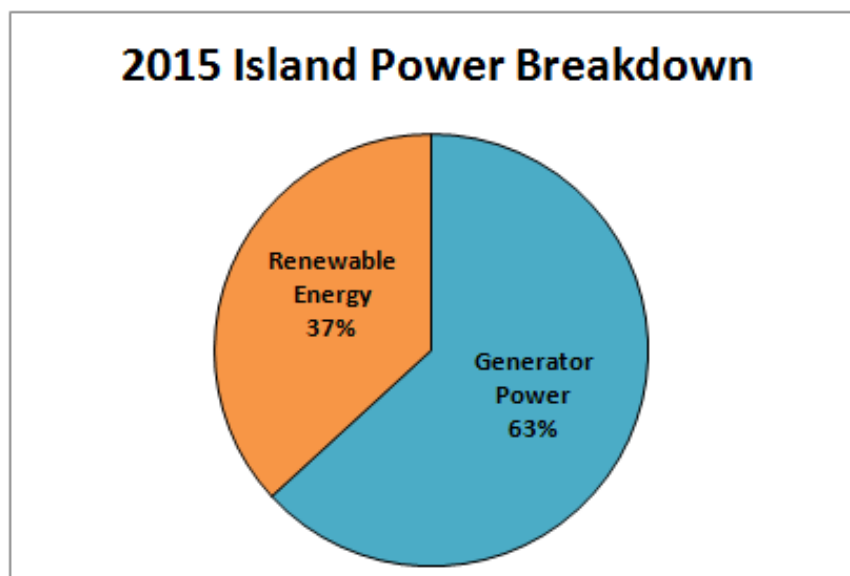
Figure 56: 2015 Island Power Breakdown

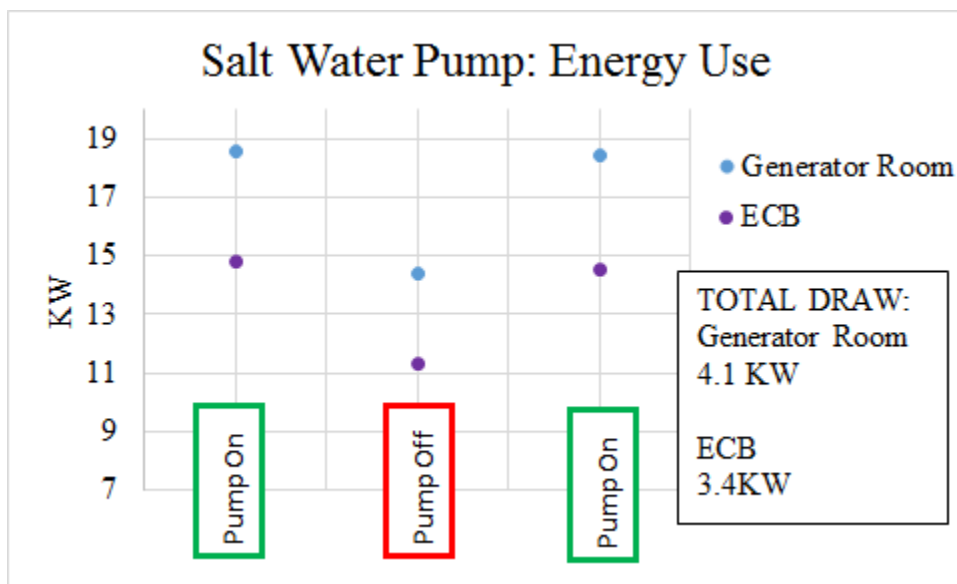
The electrical draw of the saltwater pump was calculated in two ways. First, the Eagle 440 measured the electrical draw of the system as 3.5 kW over an average of fifteen hours. The interns validated this number by manually turning the pump off for a short time while the change in energy was recorded. The manual shut down showed that the draw from the pump in the generator room was greater than that in the ECB. This was confusing, because the values should theoretically be the same. The value that was recorded by the ECB for energy draw was probably the more accurate measurement, because it was closest to the Eagle 440 data average.

Figure 58: Recorded Energy Use of Salt Water Pump from Manual Shut Off

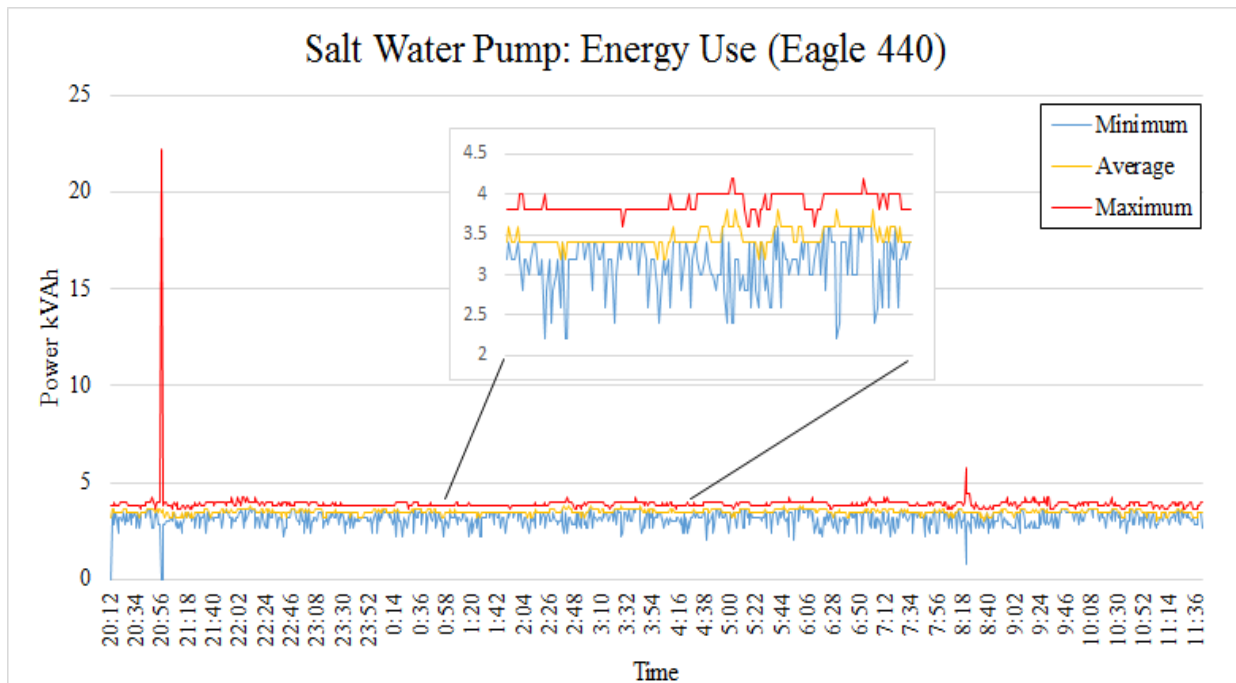
Figure 59: Recorded Energy Use of Salt Water Pump from Eagle 440 Meter

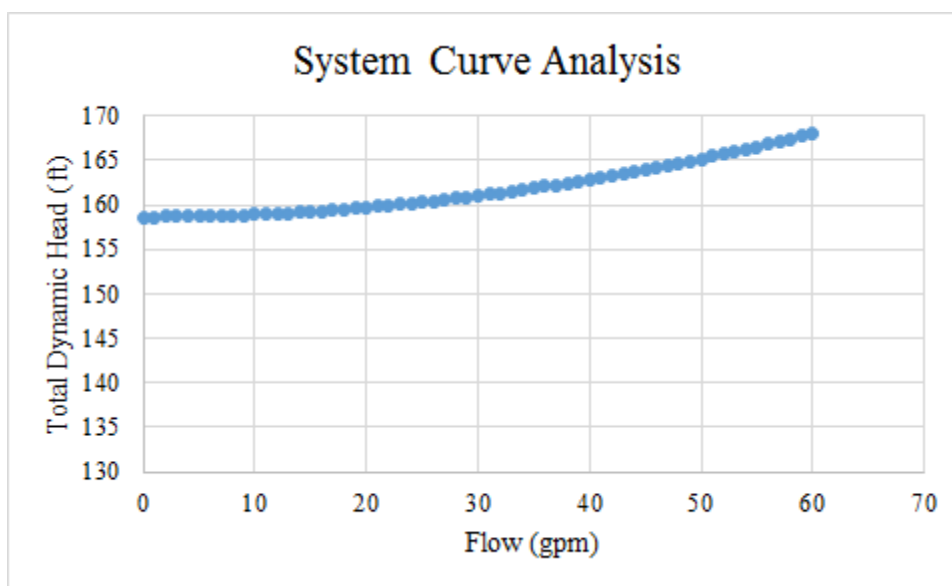
After completing calculations, the interns realized that the elevation head that they found was incorrect. They discovered that the change in elevation should have been measured from low tide to the furthest away sea table, not from low tide to the pump. Due to time constraints the interns were not able to accurately measure this elevation in the amount of time which was left. Although the elevation head is therefore incorrect, the 131.5 feet that the interns added to their values accounts for the elevation change and any friction, bends, and valves that they were not able to measure.

Figure 60: Current Pump - System Curve

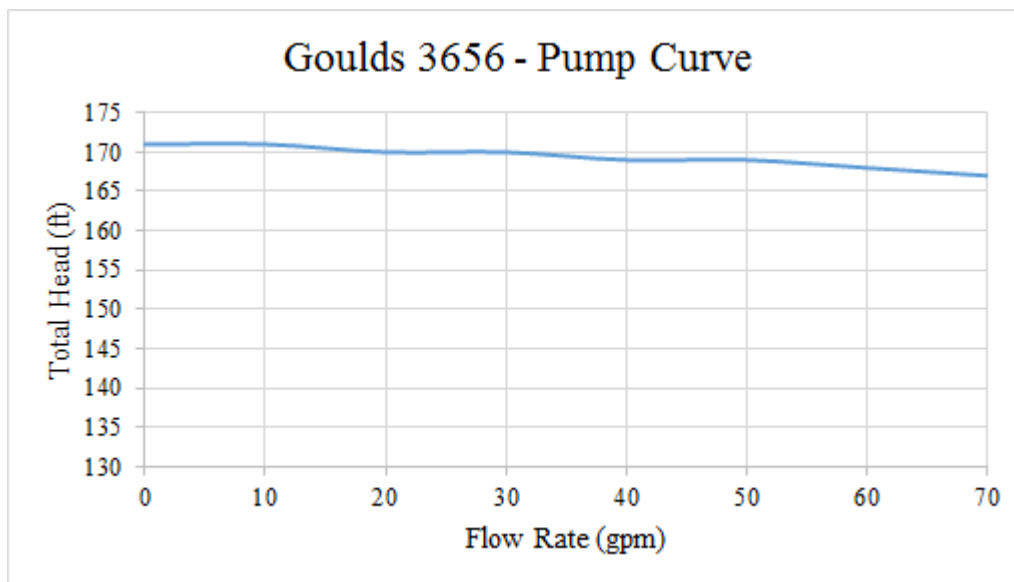
The current pump is a Gould's 3656 1½ 2x8 6¼ ". The manufacturer's published pump curve is included below. It is displayed over the flow rate ranges that the current system utilizes.

Figure 61: Current Pump - Pump Curve

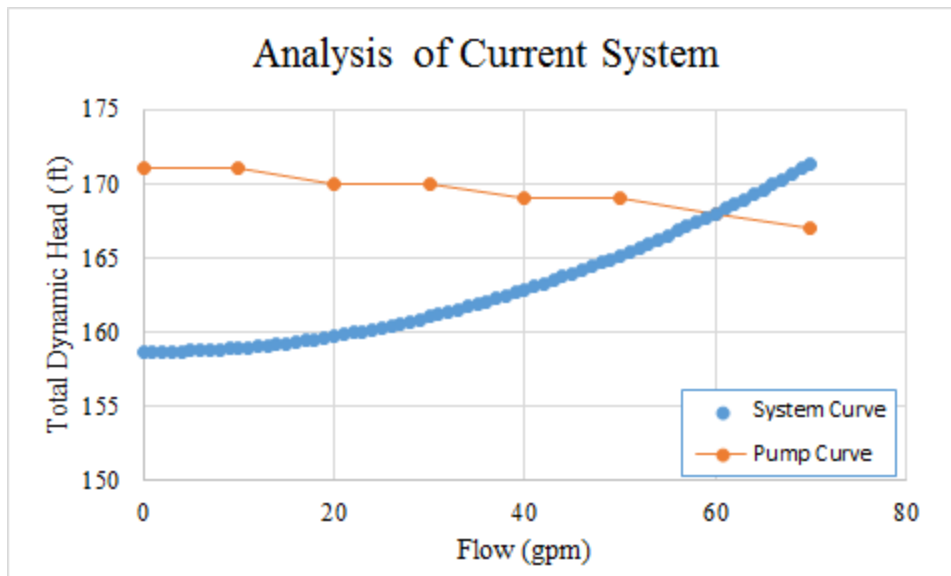
When the system curve is plotted on top of the current pump curve, the optimal operating point of the system is found to be 60 gpm. This is where the two curves meet. The pump only runs at this level when all the sea tables and two fire hoses are running. The flow data collected earlier this year showed that 6 gpm were used when facilities were opened, but before classes were in session. When PK and Loughton tables were used, 25 gpm flow was found consistently. An operating point closer to 25 or 30 gpm would optimize the system and use less energy. However, having a system slightly beyond this point, or similar to the current system would be an accurate way to account for factor of safety. The pump will degrade in operating capacity over time, lowering the pump curve. Therefore having an optimal operating point beyond 25 to 30 gpm would be ideal.

Figure 62: Operating Point of Current System

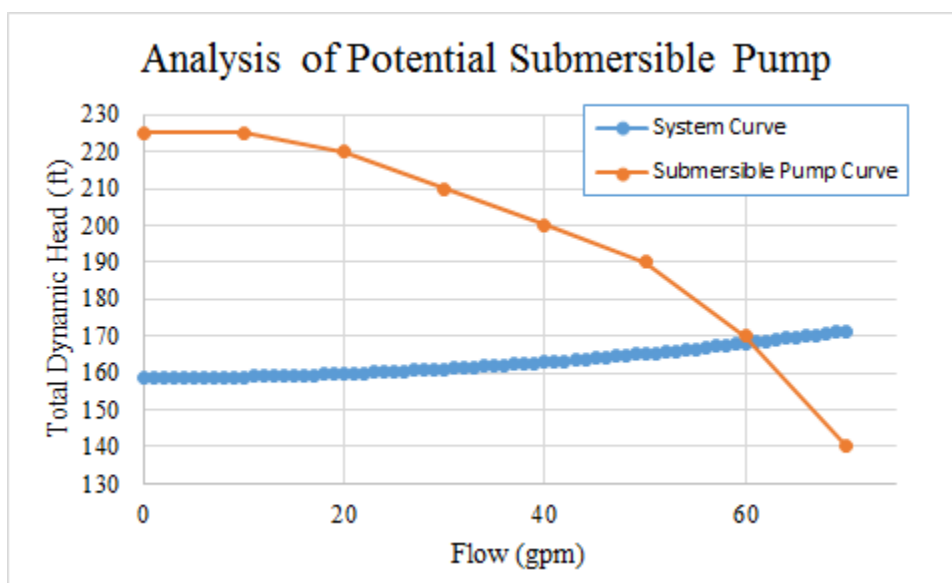
The submersible pump option when graphed with the system curve creates an optimal operating point of 60 gpm, which is the same as the current system. When the system is at 25 to 30 gpm, the available total head is much higher. This is also similar to the current system, because it operates significantly under the pump curve. However, the submersible pump would operate at a lower efficiency than the current system. This could be remedied by installing a VFD, and the pump would still be reducing energy costs and usage from the current system.

Figure 63: Analysis of Submersible Pump Option with System Curve

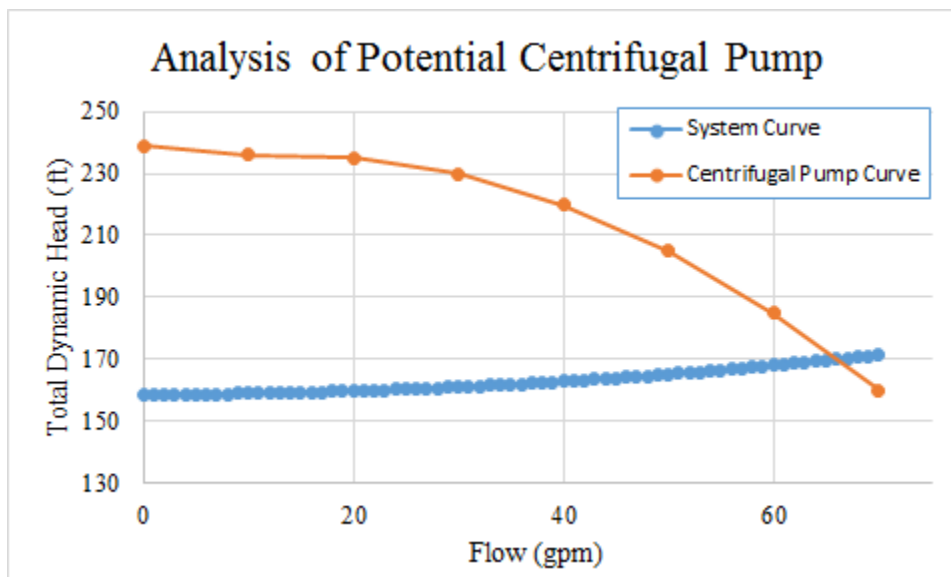
This centrifugal pump curve when graphed with the system curve yields an optimal operating point around 65 gpm. This pump installation would allow for the needs of the system to be adequately matched. The pump curve is larger than absolutely necessary to allow for pump aging over time. As the pump ages, the pump curve will be lowered. With this design, the pump will be able to meet SML's requirements for a longer period of time. While the pump will be operating at a lower efficiency when using a flow rate of 30 gpm, a VFD may rectify this problem. The pump will still be able to reduce energy costs and use compared to the current system.

Figure 64: Analysis of Centrifugal Pump Option with System Curve

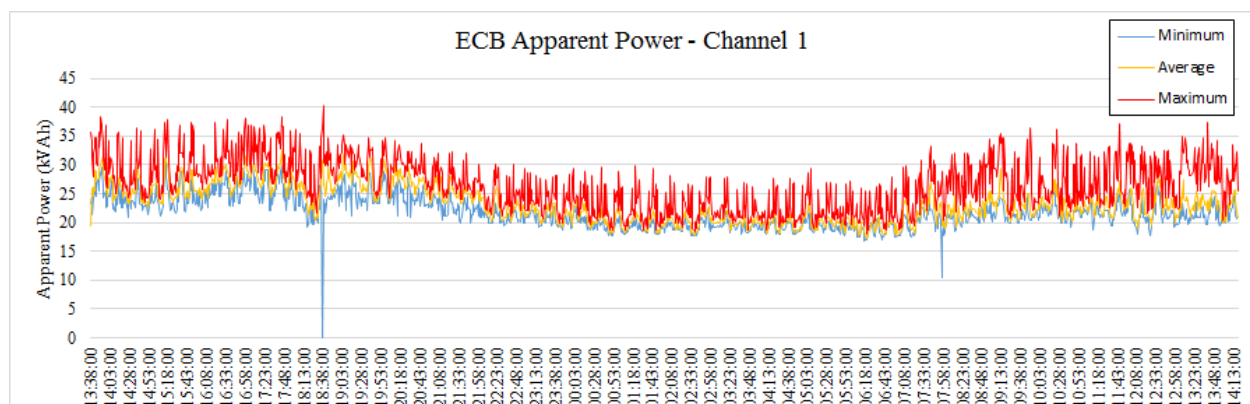
The maximum load on each building was also found from the Eagle 440 data. This value should be used if SML wants to replace any of the transformers with one that is more suited for the load of that building. An example of the data from the Eagle 440 that the maximum load was determined from is shown below.

Figure 65: Energy Conservation Building Apparent Power

The interns used this data in order to find the maximum apparent power value over the time interval. It is recommended to use a factor of safety when sizing a transformer based on this maximum power value because it was only taken over approximately a 24-hour period and that may not have been the day with the highest load on the building.

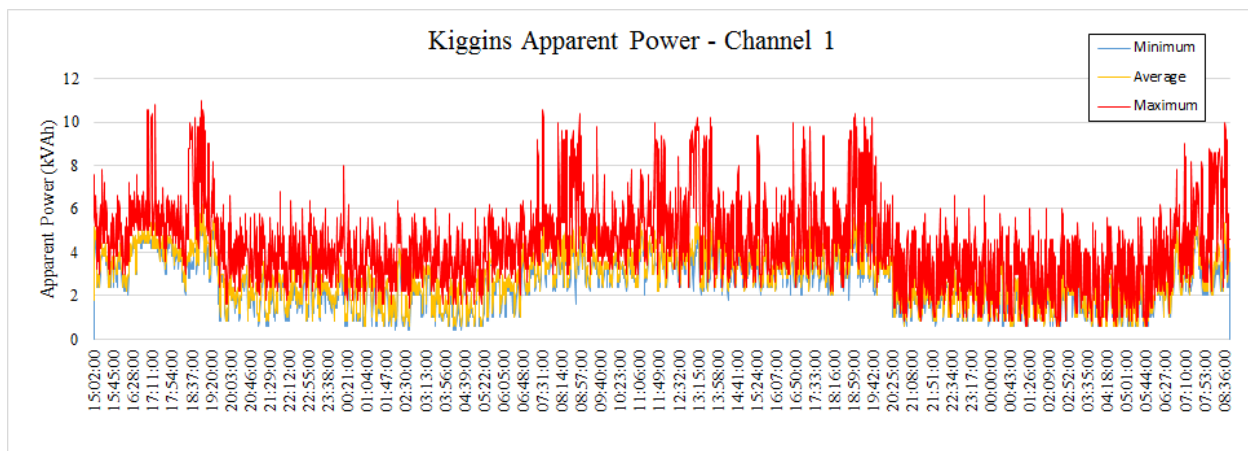
For several buildings and appliances on island, the total amount of electricity draw was measured using a power meter over the course of one or two days. A sample load profile is shown below for Kiggins Commons over 42 hours. The Kiggins apparent power includes Hamilton, Dorm 1, and Founders. These three loads are small, because there are few appliances in these buildings. The load for Kiggins can be observed fluctuating depending on the time of day, and even during meal times. The average instantaneous power found in Kiggins was 6.4 kW.

Figure 66: Electrical Load of Kiggins Commons Over 42 Hours

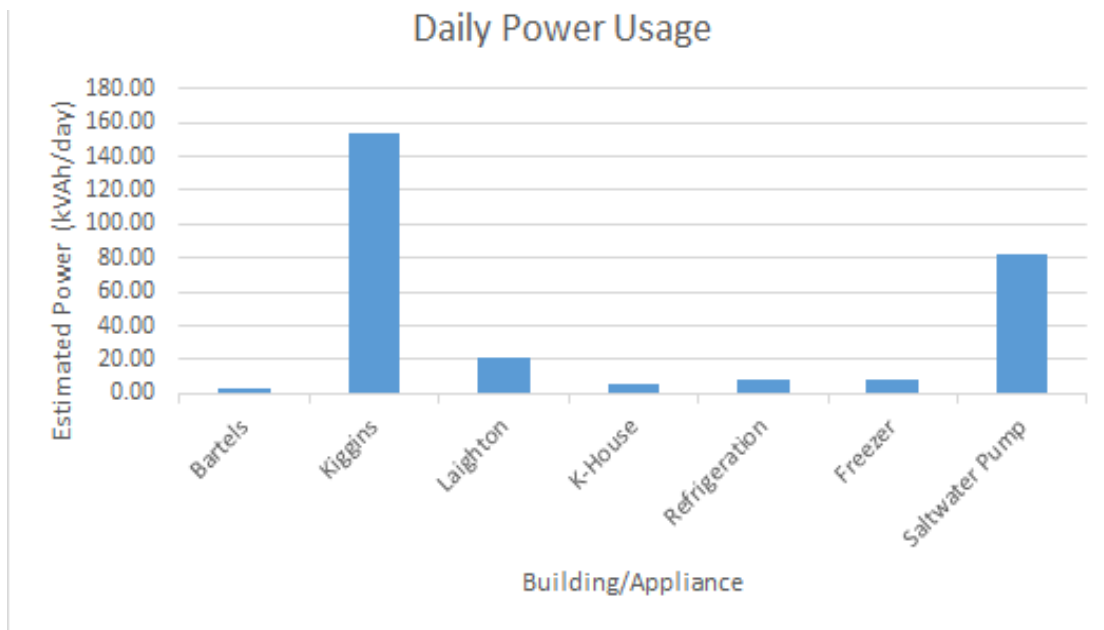
The average daily energy use for all the buildings and appliances were measured over the course of approximately one to two days. The Kiggins building transformer also distributes power to Founders, Dorm 1, and Hamilton, however these are most likely small loads in comparison because they are similar in nature to Bartels, Kingsbury House, and Laighton. This island load profile accurately reflects the need to reduce energy used in Kiggins and by the saltwater pump.

Figure 67: Average Daily Energy Use

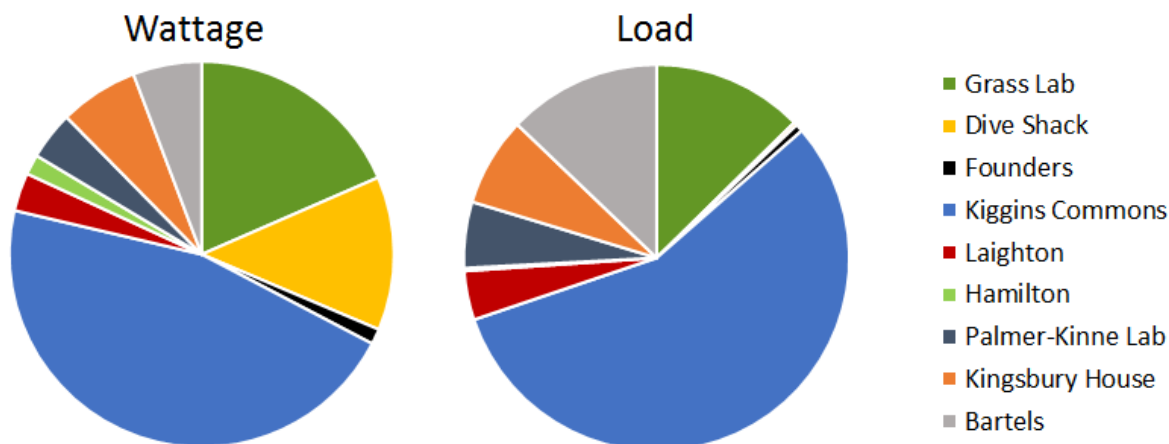
The figure below represents the percentage of both total island power (wattage) and energy (load) that each building or large appliance uses. The lighting for each building was not included in the estimate because this was included in the LED Lighting Study. The wattage chart is based solely off of total nameplate wattage of appliances in each building, while the load chart is based off of energy use of appliances based on estimated time of use. Percentage of total power and energy were used for comparison between buildings. This was done to avoid focusing on the calculated values of power and energy, which were created using potentially inaccurate estimates of total time used.

Figure 68: Percent of Total Power Used By Each Building

Some discrepancies can be noted when comparing wattage and load. The Grass Lab contributes a large portion of the total wattage because of the reverse osmosis machine, which is not run during some years. If the reverse osmosis machine is not used, the Grass Lab's load is significantly reduced. The Dive Shack wattage is very high, while in the load chart it is very low. This effect is created by the air compressor, which has a large wattage but is used sparingly throughout the season, and therefore is a small portion of total island energy. The reverse effect occurs in Bartels. The wattages of the refrigerators and freezer are calculated, but because these appliances are running almost continuously throughout the season, they create a higher overall percentage of load. The clothes washing machine in Bartels is also an appliance with a significant wattage, and if used frequently enough over the season, requires a significant amount of energy, further increase Bartels' load percentage.

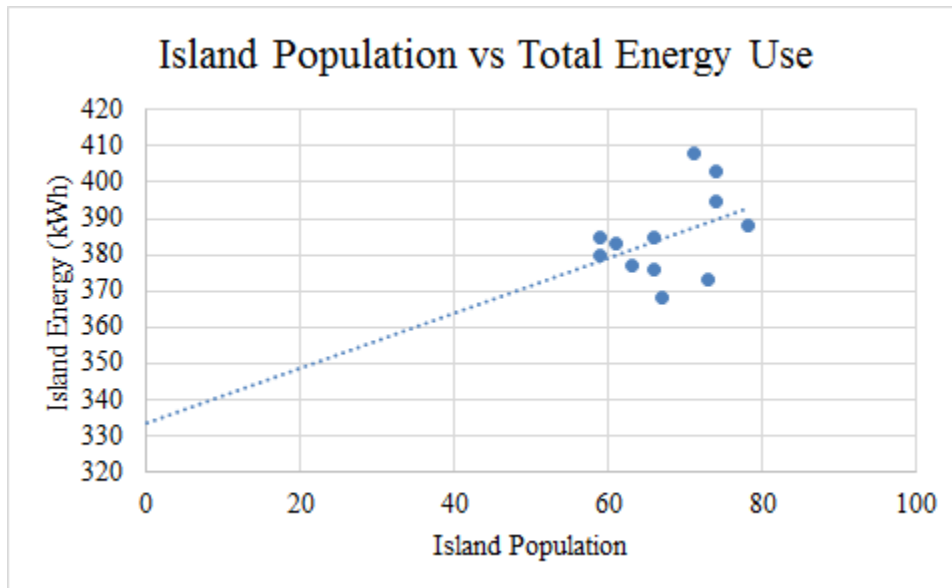
The figure below represents the island energy in relation to number of people on island. The energy was recorded in the generator room over twelve days, and the number of people who stayed overnight were recorded for each day. There was no correlation found between types or groups of people staying on the island and energy used, however further and more extensive studies should be conducted in order to fully assess whether there is a correlation. The base load of the island was estimated by projecting the trendline backwards, until the amount of energy for just one person could be observed for the island. The approximate base load of the system was found to be 335 kWh, and the average amount of energy used for each person on the island was found to be approximately 5.7 kWh.

Figure 69: Island Population by Energy Used Each Day

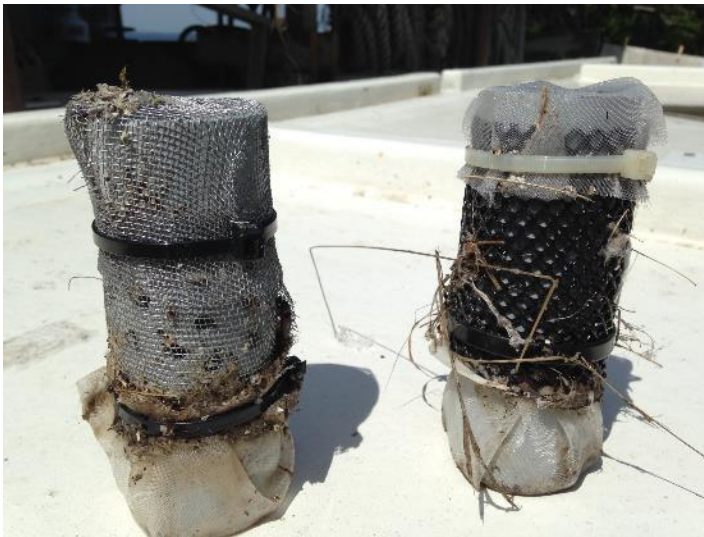
With the help of Ross Hansen, the interns built two gutter filter prototypes to prevent rooftop debris from entering the rainwater collection system and possibly clogging the pump or irrigation system. The prototypes were both made out of five-inch lengths of PVC pipe with many holes drilled into them. Filter A had a fine wire mesh wrapped around it, and Filter B had a thicker plastic mesh with larger holes wrapped around it. The purpose of the two mesh wrapping sizes was to compare the quantity of debris that made it through the filters and into the collection tanks. A bag filter catchment was attached to the bottom of each gutter filter to catch the debris that went through each filter.

Figure 70: Filter A (left) and Filter B (right)

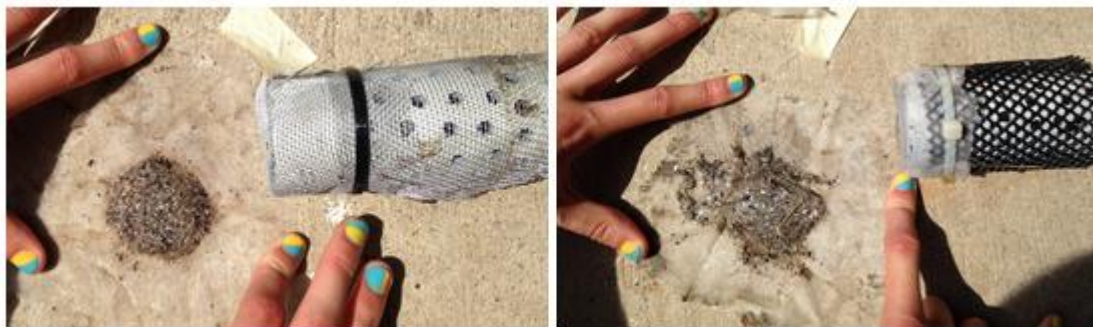
After a short rainfall event, the catchment devices were removed and the performance of the filters was assessed. It was determined that Filter A was more effective at removing debris than Filter B. Both filters had let sandy particles through and the outer holes had become partially clogged. Inspection of the gutters revealed that the debris that did not go through the filters settled out in the gutters. However, the filters and gutters need to be cleaned of debris after every rainfall event to prevent clogging and gutter overflow.

Figure 71: Effectiveness of Filter Designs

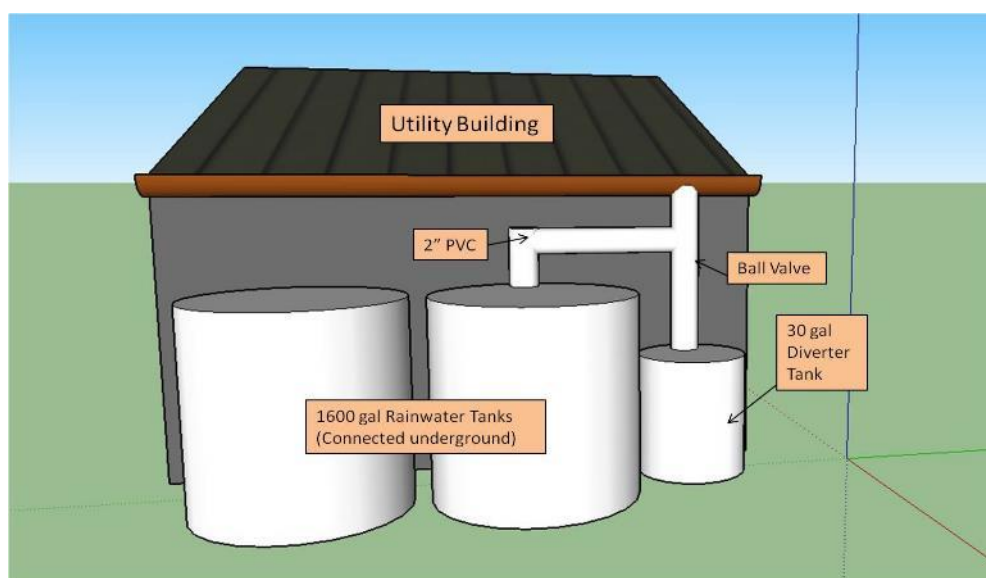
The diverted first flush water enters a separate collection tank. When this tank is full, a ball valve in the downpipe floats upward and blocks the entrance of the first flush tank, directing the rest of the water into the rainwater collection tanks. After the rain stops, a valve in the first flush tank is opened to release the discarded water, resetting the system for the next rainfall event. A simple CAD drawing of what the first flush system on the roof of the Utility Building could look like.

Figure 72: First Flush CAD Drawing

\*Not shown in this picture: it is important that the right side of the gutter be lowered slightly so that the water and debris will run toward the downspout.

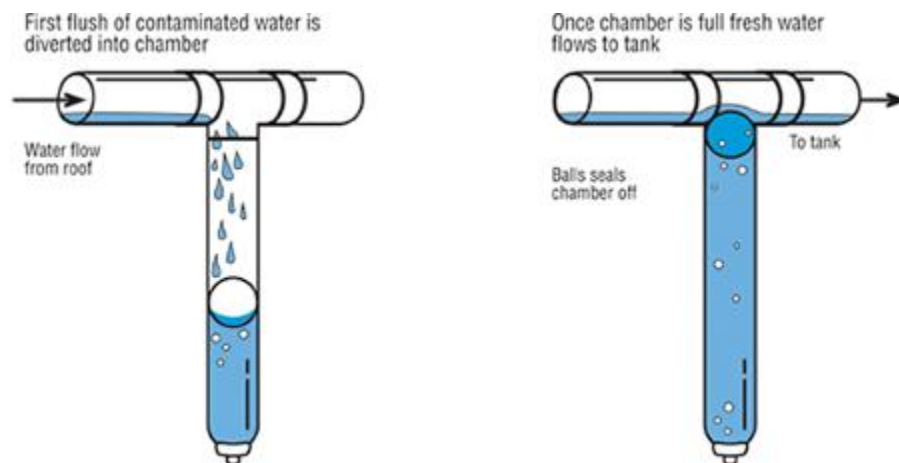
Figure 73: First Flush Diagram

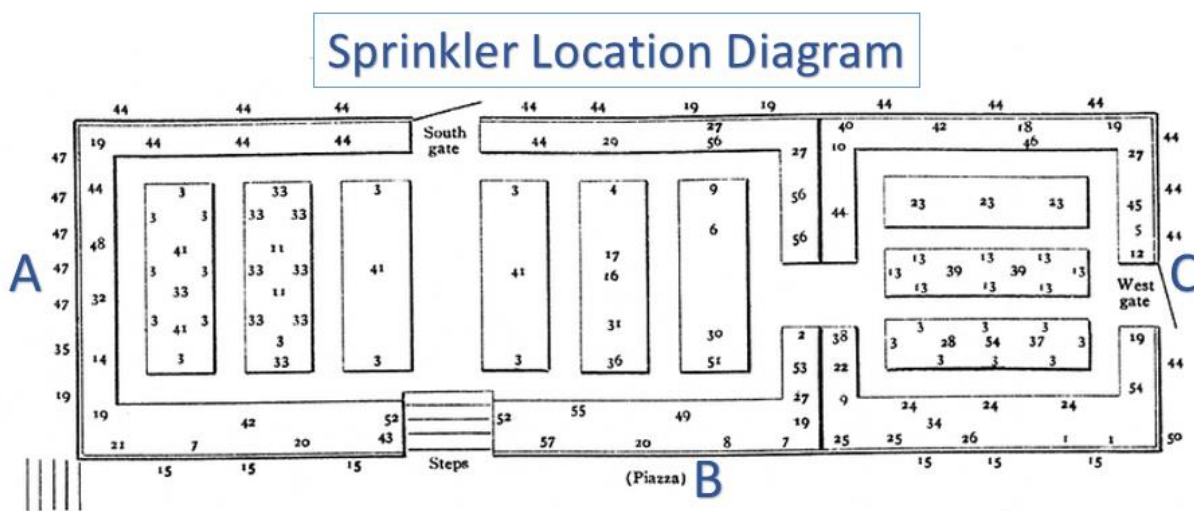
The current watering system consists of three sprinkler heads located on the garden fence at the positions shown in the figure below.

Figure 74: Current Sprinkler Locations

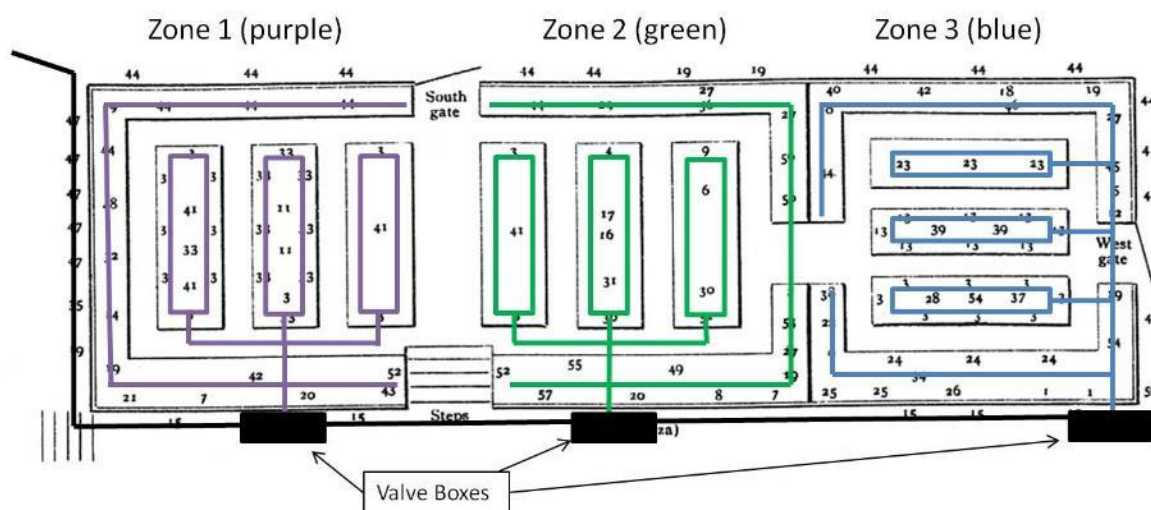
The interns evaluated the possibility of implementing a drip irrigation system to water Celia Thaxter's Garden. Drip irrigation is more efficient than overhead sprinklers because water is applied directly to plant roots, so very little water is lost to evaporation. Rene Gingras, a UNH professor specializing in rainwater collection and drip irrigation systems, was consulted for the design of the drip hose layout and for a materials cost estimate. It was decided that three irrigation zones will be most effective at delivering water to where it is needed with sufficient flow in the pipes. Each of these three zones should have their own valve box to house a filter system, pressure regulator, and valve, all of which are included in a starter kit. The layout of the drip irrigation hose was used to calculate head due to bends and fittings.

Figure 75: Drip Irrigation Hose Layout

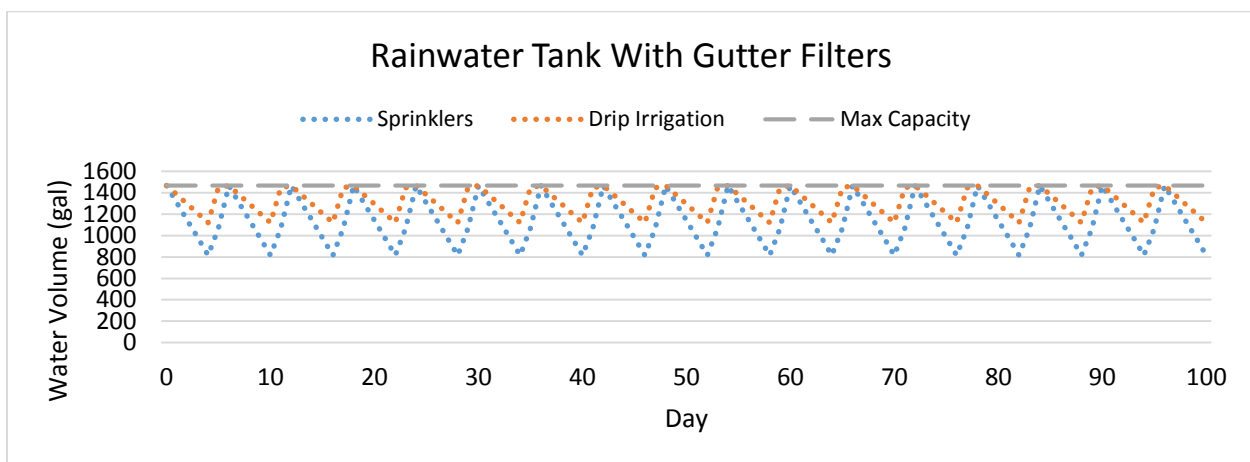
Models were created to compare the water volume in the tanks for each watering method over the course of the 100 day season. The tanks were assumed to be full at the start of the season, with a maximum capacity of 1,466.67 gallons. The models operate on a six day cycle. Water is removed from the tank to water the garden for four consecutive dry days. The fifth and sixth days represent a rainfall event. On these days, water is added to the tank by rainfall, and is only removed from the tank for watering the garden on the fifth day because SML staff manually turn off the watering system on the sixth day to prevent over-watering.

Figure 77: Fullness of Rainwater Tank With Gutter Filters

Regardless of the filtration system used, the amount of rainwater in the tanks is more than sufficient for drip irrigation. The lower water usage due to the drip system would ensure that the tanks are refilled to maximum capacity during each rainfall event. For the sprinkler system, the tanks would be depleted to a lower volume between rainfall events. With the addition of first flush to the sprinkler system, the rainfall would not be able to refill the tanks to maximum capacity. This would result in an overall decline in rainwater volume over the course of the season, but would still not fully deplete the tanks by the end of the season.
