# Sustainable Engineering Internship

*26 July 2015*

Chelsea Kimball, Dylan Masi, Susan McGrattan, Marisa Zellmer

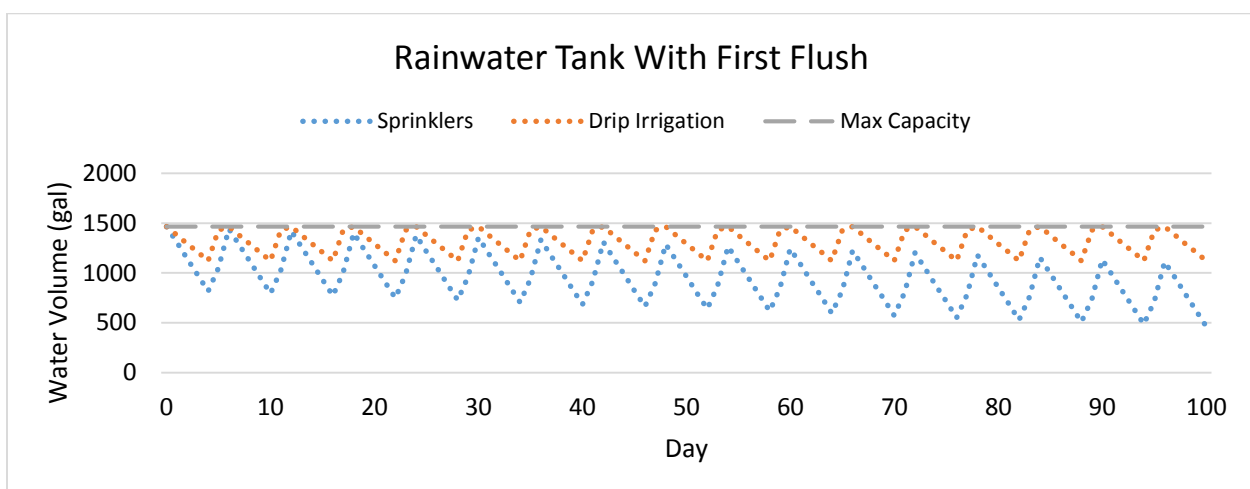
Figure 78: Fullness of Rainwater With First Flush

Regardless of the filtration system used, the amount of rainwater in the tanks is more than sufficient for drip irrigation. The lower water usage due to the drip system would ensure that the tanks are refilled to maximum capacity during each rainfall event. For the sprinkler system, the tanks would be depleted to a lower volume between rainfall events. With the addition of first flush to the sprinkler system, the rainfall would not be able to refill the tanks to maximum capacity. This would result in an overall decline in rainwater volume over the course of the season, but would still not fully deplete the tanks by the end of the season.

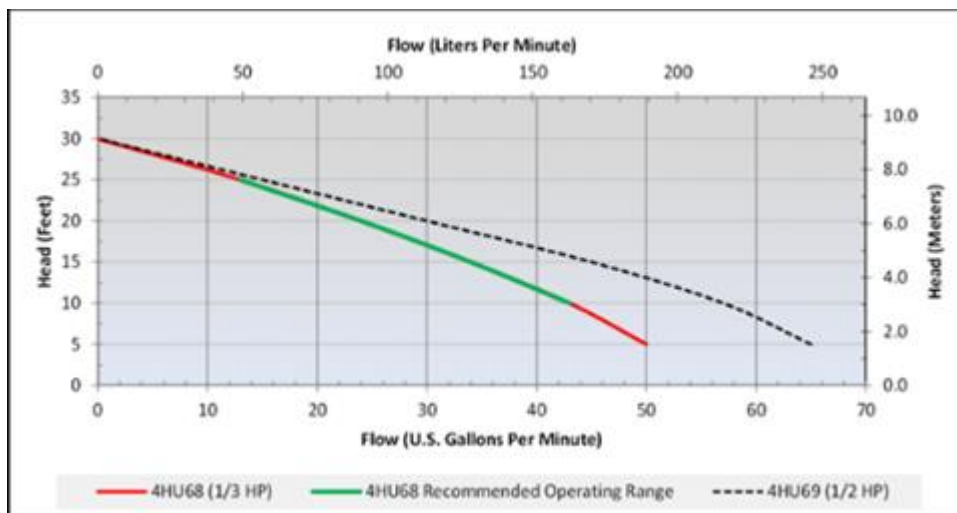
After comparing the pump options from Table 17, the interns recommend that SML get a Dayton  $\frac{1}{3}$  hp submersible sump pump. This pump is made of cast iron, which means the pump will be reliable for several years. Below is the pump curve from the manufacturer.

Figure 79: Pump Curve of Recommended Pump

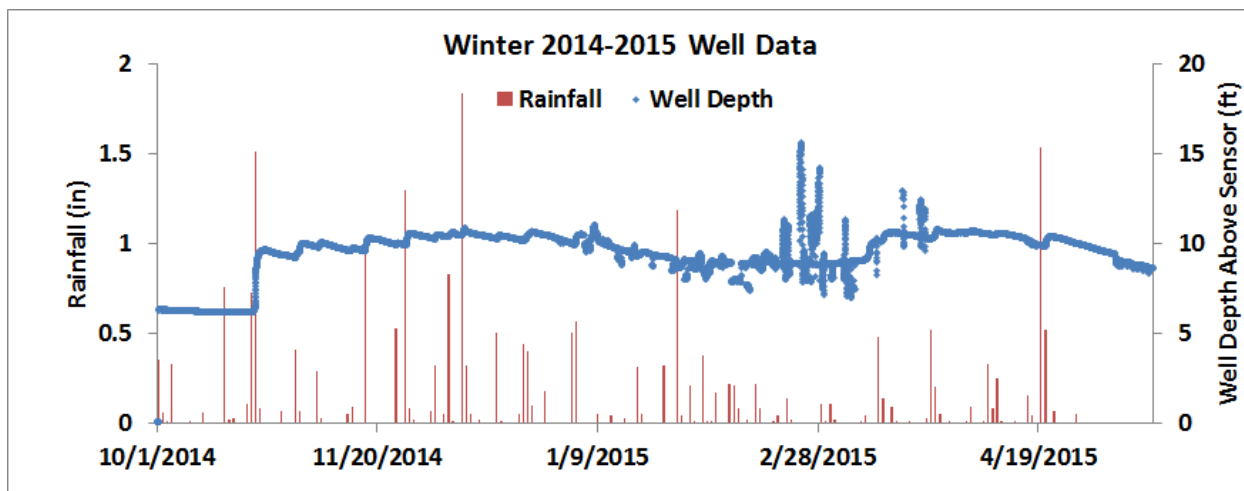
The well depth measured in 15 minute intervals and daily rainfall data taken from October 1st, 2014 to May 15th, 2015 are displayed below. Increases in well depth tend to be attributed to rainfall events that occur in the few days preceding the increase. The spikes in late February and early March are most likely due to snowmelt, in which the amount of water recharging the well is dependent on temperature in addition to precipitation.

Figure 80: Winter 2014-2015 Well Data

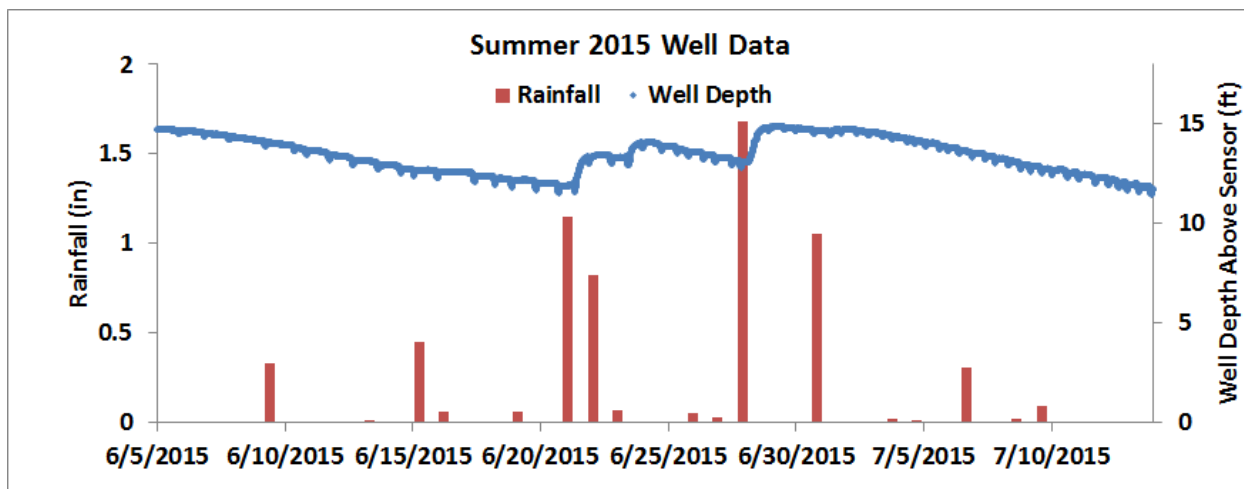
The sensors were deployed again from June 5th, 2015, to July 14th, 2015. The smaller dips in well depth are caused by drawdown from island use and the subsequent pumping. The larger increases are recharge from the rainfall events.

Figure 81: Summer 2015 Well Data

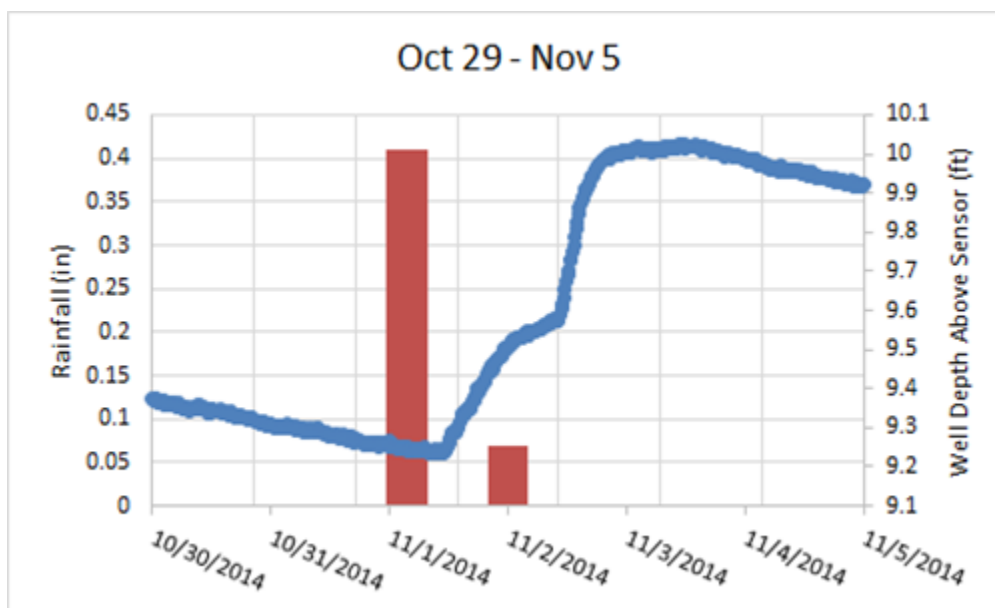
Rainfall events during time periods of no pumping and non-freezing temperatures were identified and evaluated to determine the total precipitation (P) and change in well depth ( $\Delta H$ ). A sample rainfall event on November 1-2, 2014, with a total precipitation of 0.48 inches and a change in well depth of 0.79 feet is shown below.

Figure 82: Rainfall and Well Height

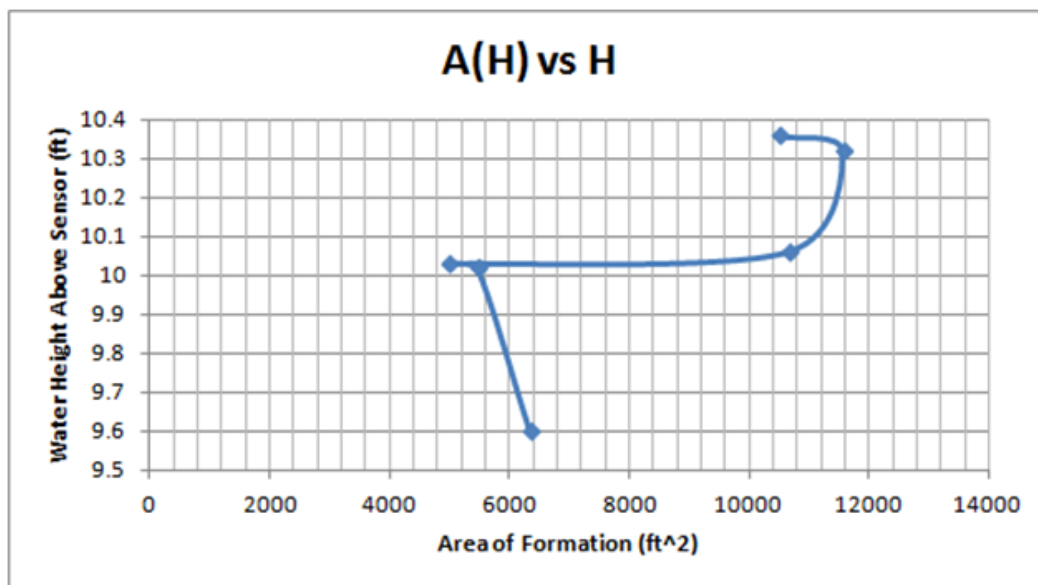
*Figure 83: Area with Respect to Height*

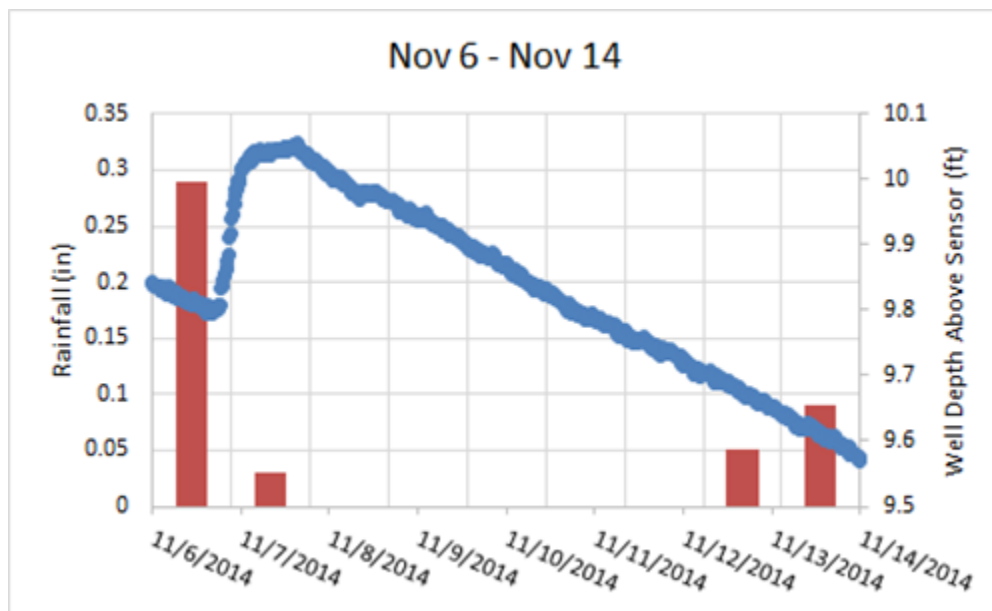
Time periods of no precipitation, no pumping and non-freezing temperatures were identified and evaluated to determine the change in well storage ( $\Delta S$ ). Since there is no water entering the well from rainfall and none being pumped out for island use, the change in storage is equal to leakage. A sample time period with no precipitation on November 8-12, 2014 with a change in well depth of 0.36 feet is shown below.

*Figure 84: Calculating Leakage Between Rainfall Events*
